ZBA Application (22-021)
1391 Crystal Lake Rd,
Galway, Con 10, Lot 25, R45R10829 Part 25, R644584 Part 4 & 5.
Municipality of Trent Lakes (Kinmount)
Fredrick and Mildred Engelage

Shoreline Restoration Plan

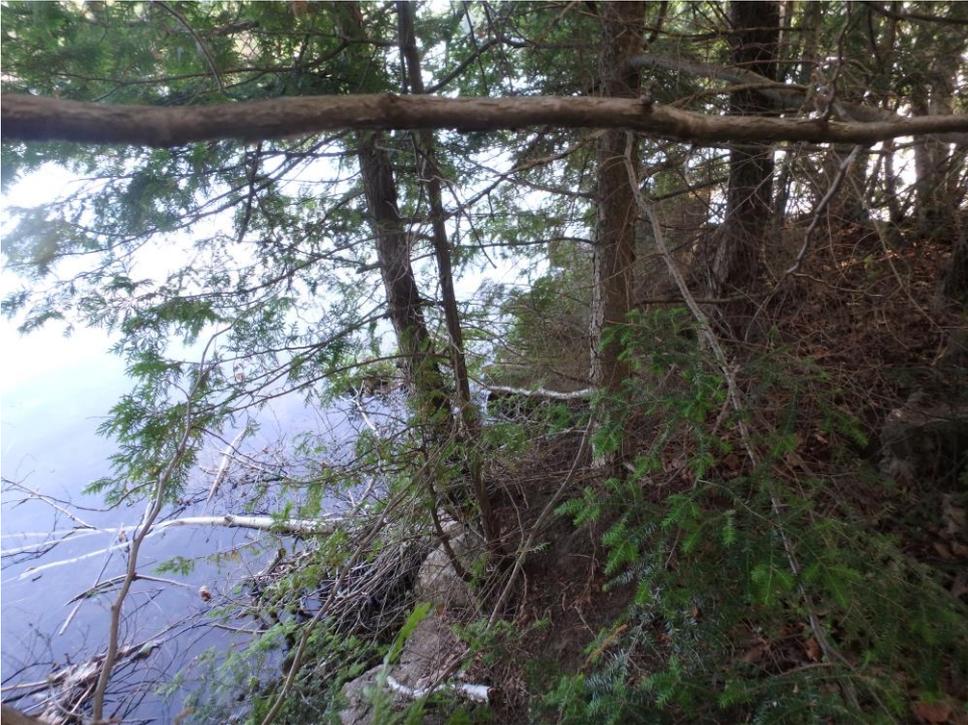
The shoreline contained overhanging cedar trees, some with multiple stems, some green ash and white birch. The original shoreline had several dense patches of trees. Photos 1 and 2 were taken on June 24 ,2021.

Photo 1. View of western shoreline (June 24, 2021)

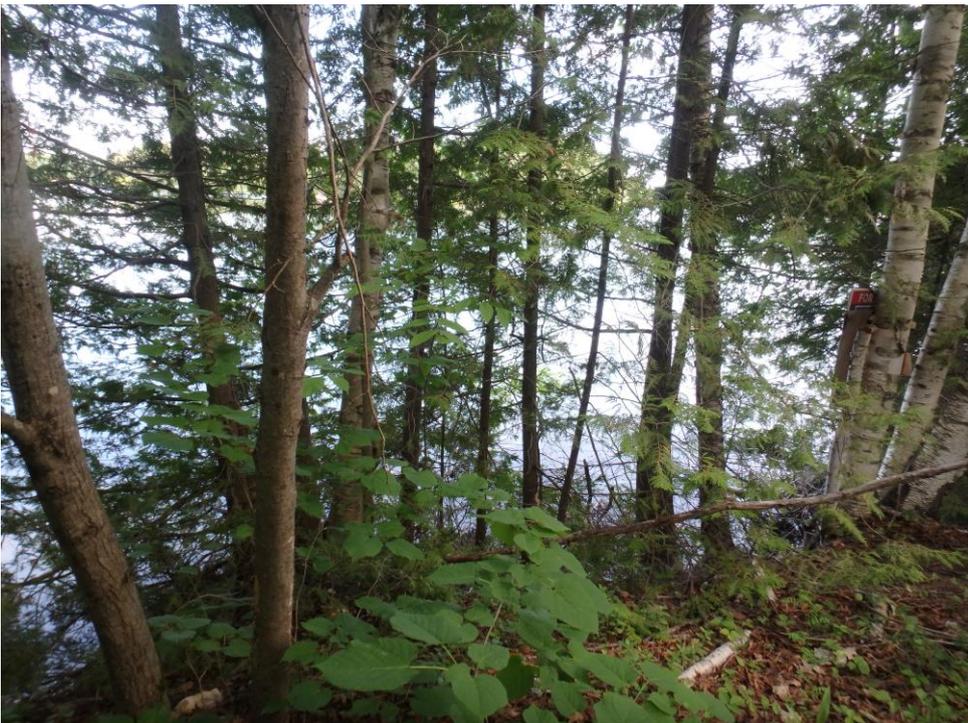
Photo 2. View of eastern shoreline (June 24, 2021)

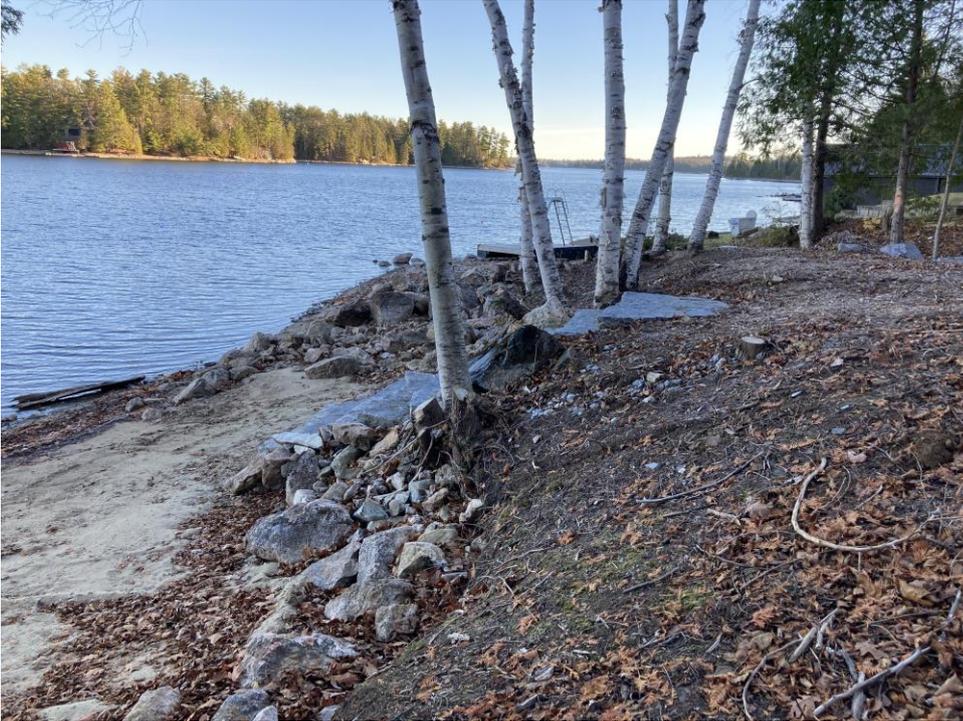
The conditions on the day of our recent site visit on November 9, 2022, confirmed that shoreline trees had been cut down, but the stumps remained, as well as the root wads. This has maintained the stability of the slope and shoreline. Groundcover vegetation was still intact.

Photos 3 and 4 show the stumps and the location of those along the shoreline. Selective trees were cut but 8 white birch and 4 cedars were retained. In total 21 trees were removed. This included the following trees in table 1 with their dbh.

Photo 3. View of western portion of shoreline. Exposed sand due to normal fall drawdown of entire lake by 60-90 cm. (GHD, November 9, 2022),

The frontage along the shoreline is less than 80 feet with some white birch in the 13-19 cm dbh range left standing. The placement of the new trees is recommended predominantly on the western portion of the shoreline, as the eastern part is where access to the shore exists and where a previous dock and likely new dock will be located. This is also adjacent to the neighbouring property that has a more open area. By replacing trees west of the staircase and active area, this will create a forested area that is contiguous with the neighbours forested lot and shoreline trees in that area.

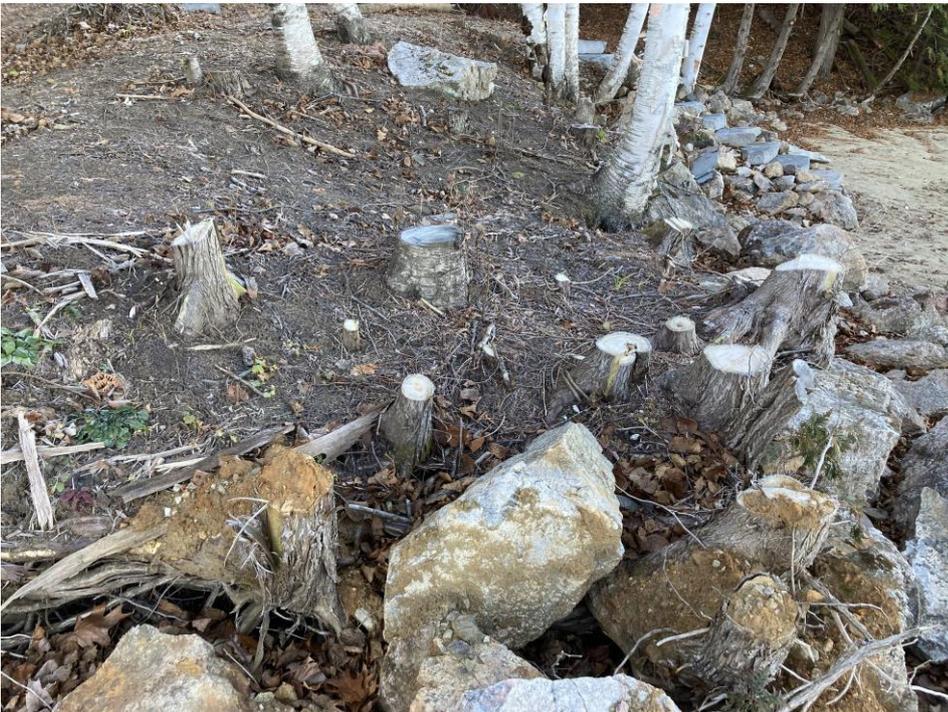
Photo 4. View of eastern portion of shoreline. (GHD, November 9, 2022),
