ENVIRONMENTAL IMPACT STUDY

**GRANITE RIDGE
SUBDIVISION PHASE 2
TOWNSHIP OF
GALWAY-CAVENDISH & HARVEY**

P/N 09-2361

October 2012

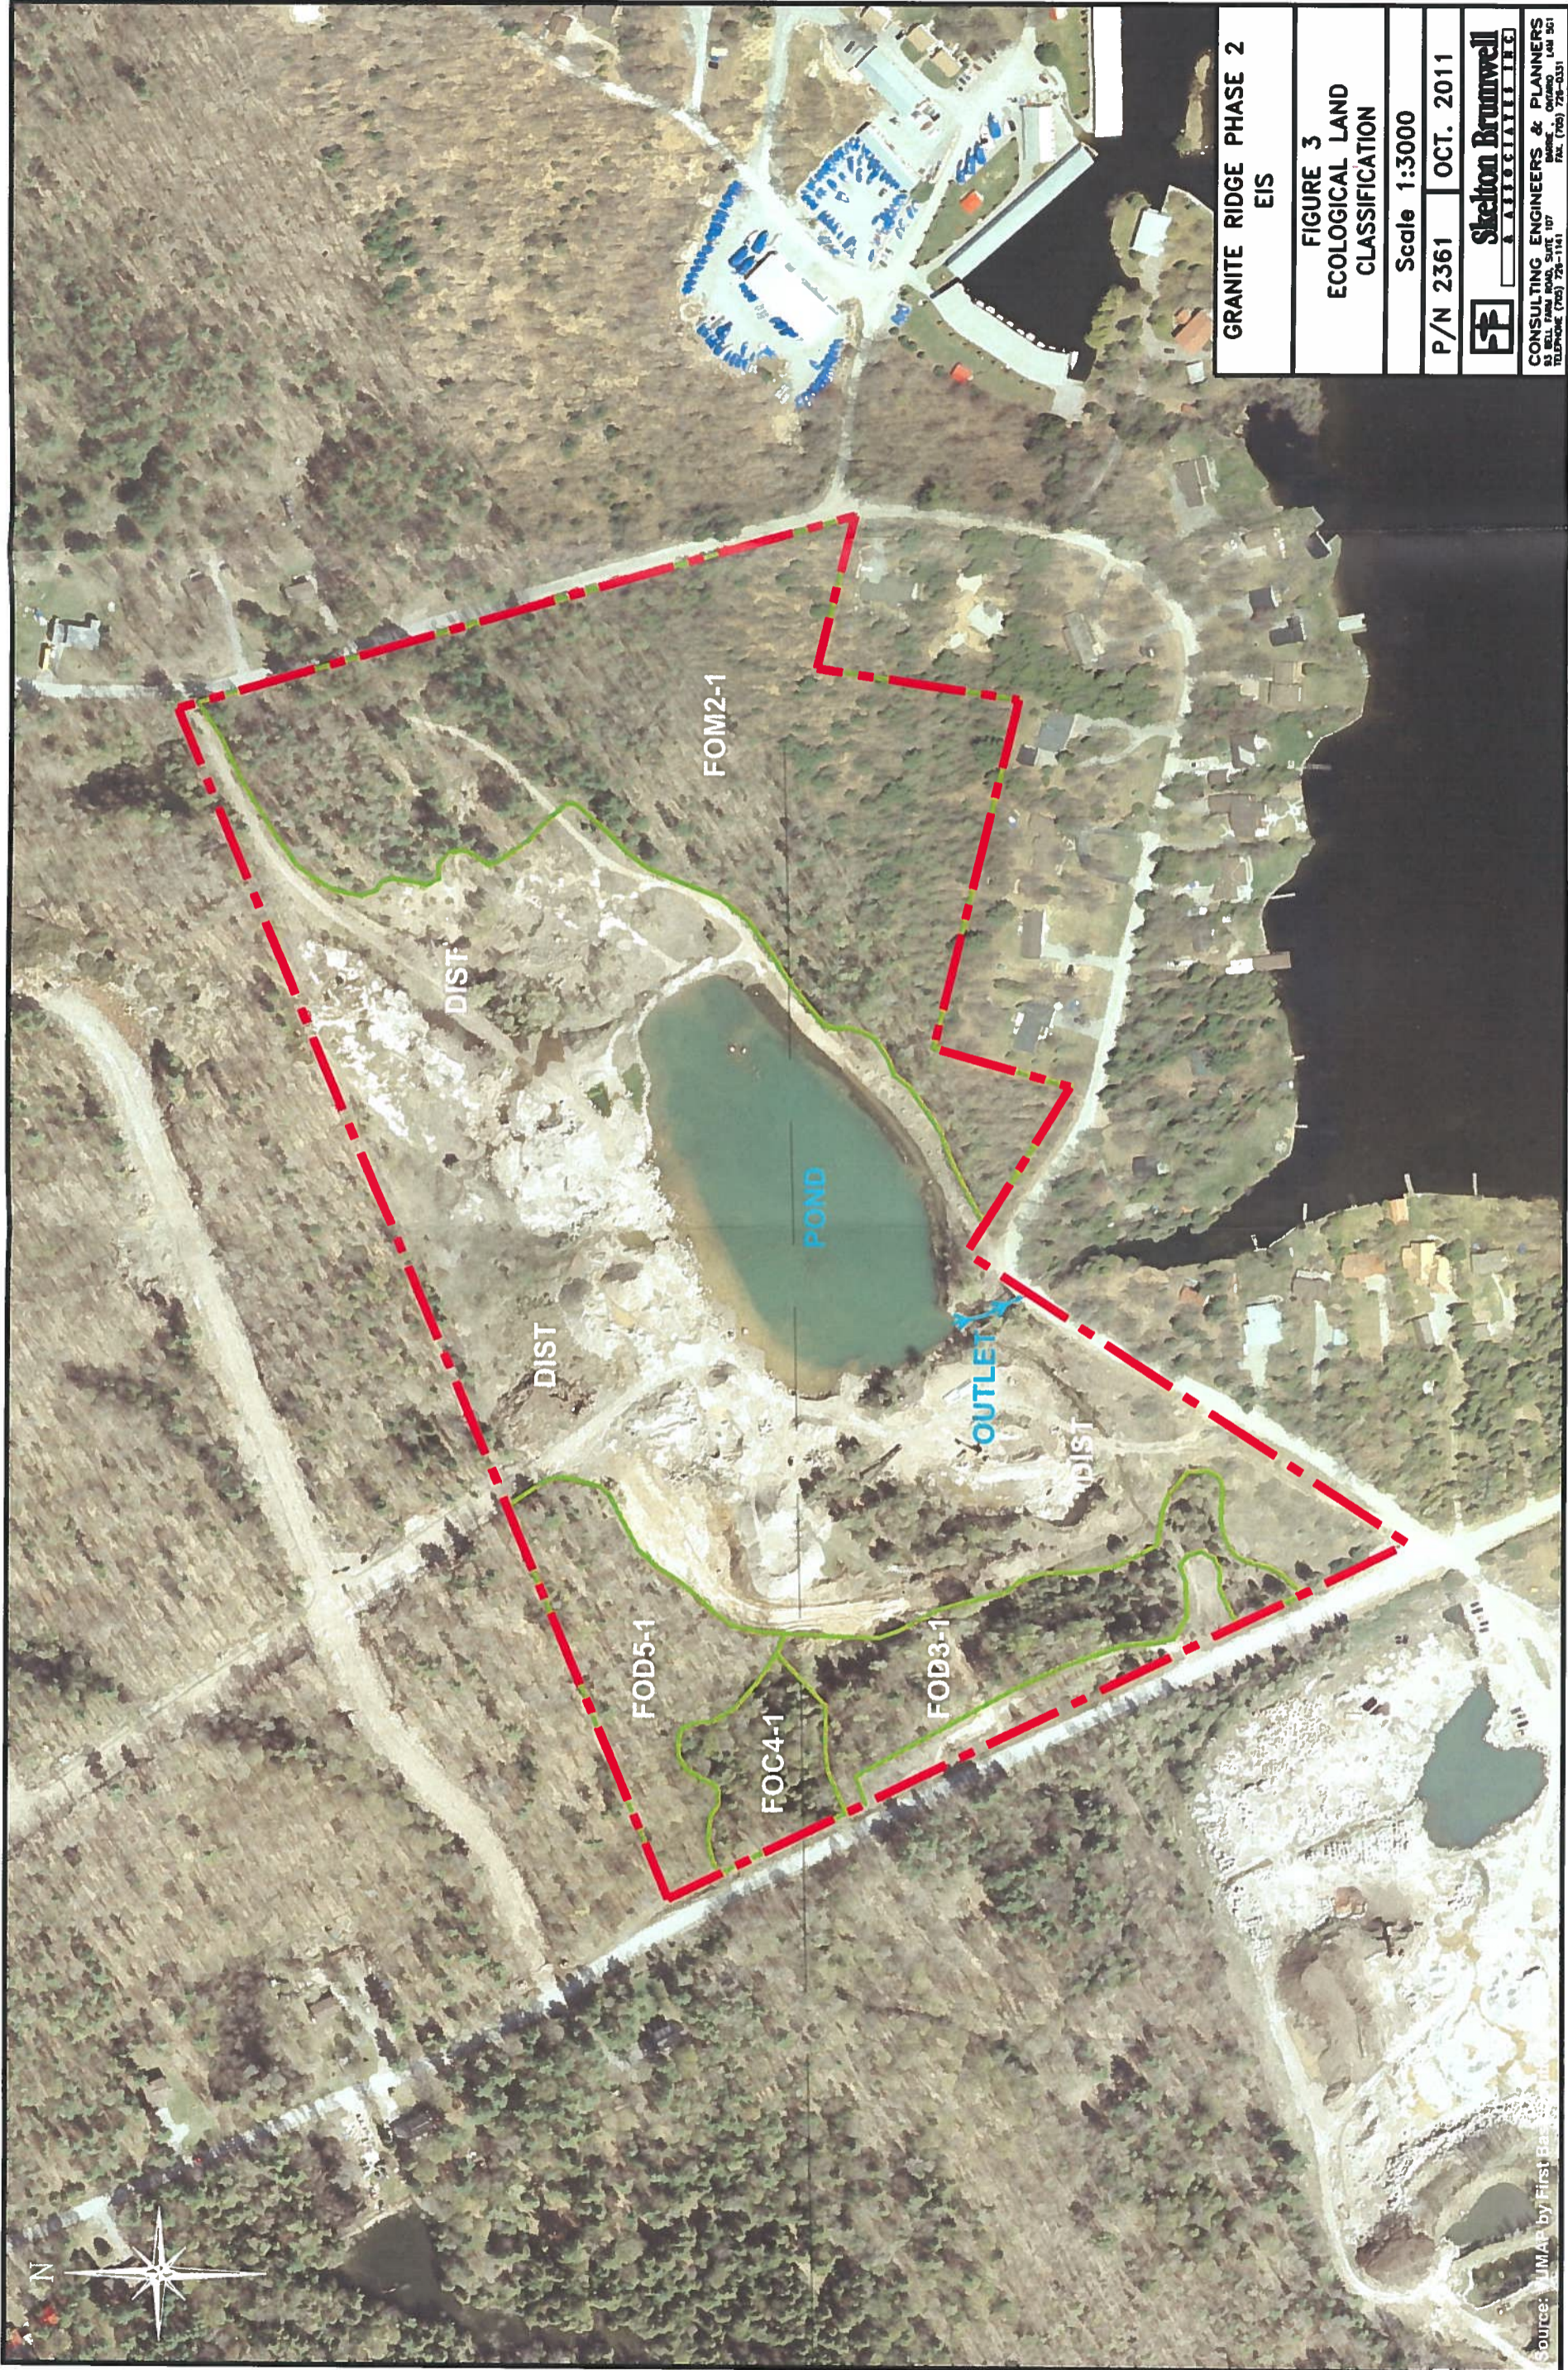
GRANITE RIDGE PHASE 2 EIS	
FIGURE 3 ECOLOGICAL LAND CLASSIFICATION	
Scale 1:3000	
P/N 2361	OCT. 2011

Vegetation communities were identified within the study area using ELC to the Vegetation Type shown on Figure 3 and Photo Page 1. Detailed descriptions of communities are included below.

An existing groundwater fed pond is present near the centre of the site (see Figure 2 & 3). This pond is the result of extraction below the water table during previous use of the site as a gravel pit. The pond drains through a drainage channel (see Photo Page 1) to a culvert which crosses Adam and Eve Road and then outlets to Buckhorn Lake.

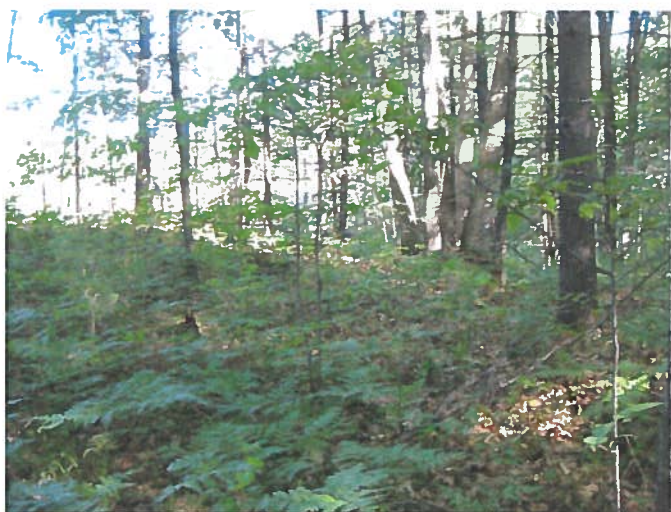
FOD5-1: Dry-Fresh Sugar Maple Deciduous Forest Type

Dominant cover is mature hard maple (*Acer saccharum*) with associates including ironwood (*Ostrya virginiana*), red maple (*Acer rubrum*), large-toothed aspen (*Populus grandidentata*) and the occasional white pine (*Pinus strobus*). Understory and shrub cover is hard maple, ironwood and round-leaved dogwood (*Cornus rugosa*). Groundcover included Canada mayflower (*Maianthemum canadense*), bracken fern (*Pteridium aquilinum*), and rosy-twisted stalk (*Streptopus roseus*).

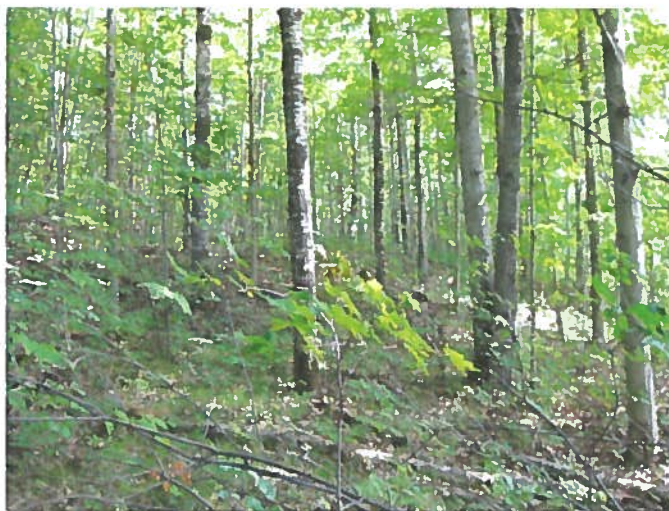
FOD3-1: Dry-Fresh Poplar Deciduous Forest Type

Dominant cover is large-toothed aspen, trembling aspen (*Populus tremuloides*) with associates of scots pine (*Pinus sylvestris*), white ash (*Fraxinus americanus*), eastern white cedar (*Thuja occidentalis*) and hard maple. Understory and shrub cover is poplar, round-leaved dogwood, eastern hemlock and hobblebush (*Viburnum lantanoides*). Groundcover included Canada mayflower, bracken fern, large-leaved aster (*Eurybia macrophylla*), poison ivy (*Toxicodendron radicans*), and wild sarsapilla.

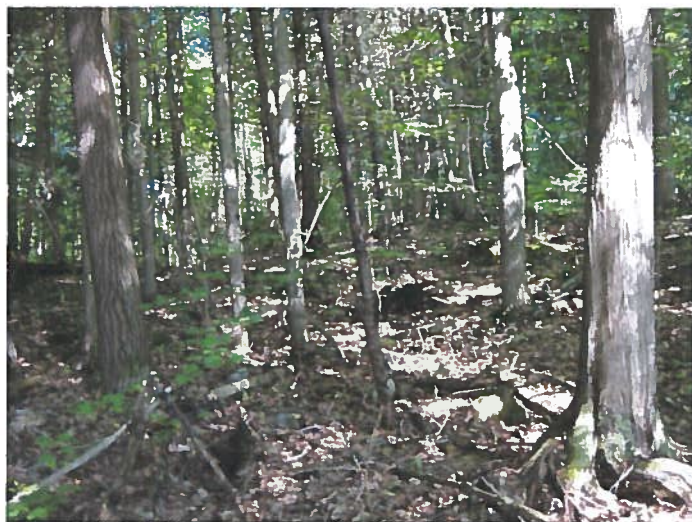
FOC4-1: Fresh-Moist White Cedar Coniferous Forest Type

Dominant cover is eastern white cedar with associates of trembling and large-toothed aspen, hard maple and white birch (*Betula papyrifera*). Understory and shrub cover is sparse, with eastern hemlock, green ash (*Fraxinus pennsylvanica*) and cedar. Groundcover included common helleborine (*Epipactis helleborine*), white trillium (*Trillium grandiflorum*) and spinulose wood fern (*Dryopteris carthusiana*).

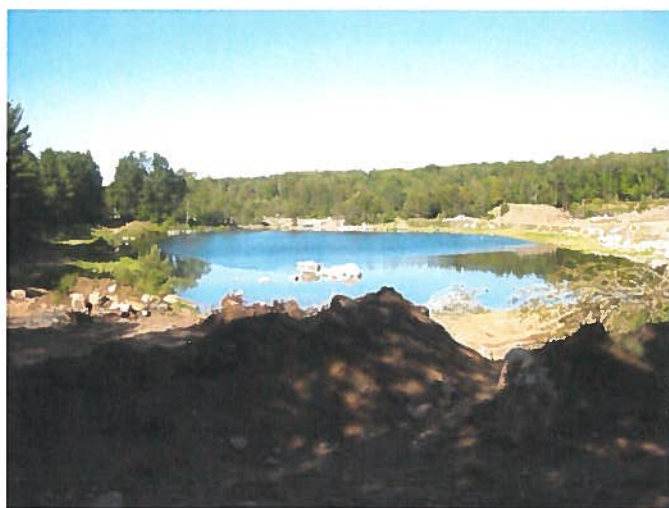
Pond

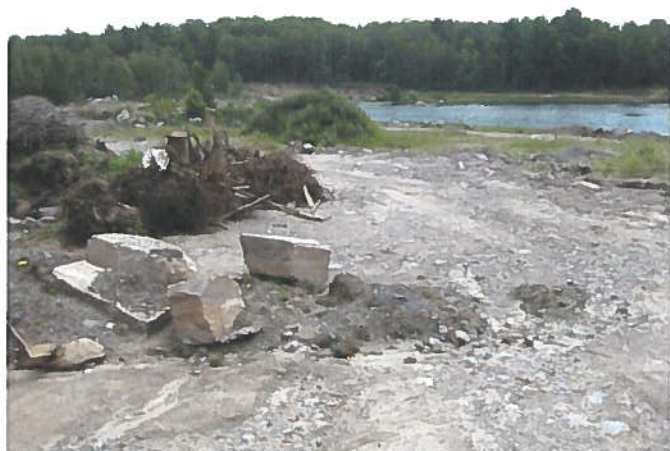
Example of Disturbed Area

Disturbed areas on the property were not classified. They are the result of previous aggregate extraction (gravel pit) and during site visits disturbed areas were being utilized. Small areas of natural succession/regeneration have occurred, resulting in small communities of poplar woodland, cultural staghorn sumac (*Rhus typhina*) thickets and old field cultural meadow.
