# FISH HABITAT IMPACT ASSESSMENT

## Granite Ridge Subdivision—Phase 2

### Municipality of Trent Lakes

April 2014

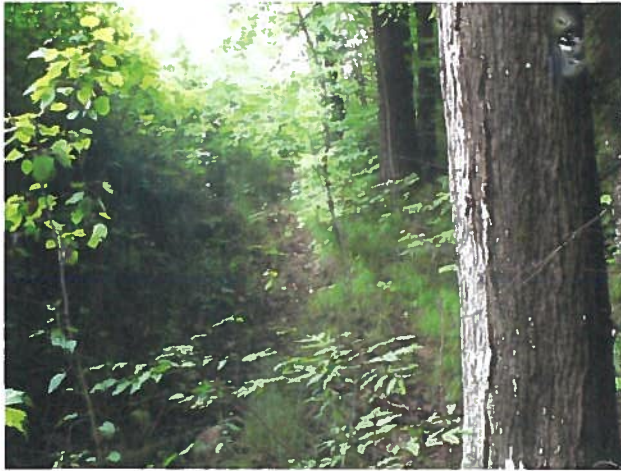
**Photo 1.** Start of watercourse in northwestern portion of subject property, Lot 25 and 26 (June 11, 2013).

A natural channel originates from a series of groundwater upwelling's in the northwest corner of the subject property (**Figure 2**). The upwelling's appear and then disappear a number of times before a defined channel forms. The natural channel exists for 260 m prior to entering a ditch system along the internal roads. The characteristics of the defined channel are described as follows: water temperature was 10 °C with an air temperature of 23 °C (13:00hr); substrates were variable ranging from sand and organics to areas with gravel, cobble and boulders; average channel width was approximately 1 m with wet width 0.5 m; source was ground water; riparian vegetation was well established and canopy cover was 100%. This watercourse did not appear to support any fishery and there are likely periods during a dry year that there is no flow. Presently it has no direct connection to the pond features that contain fish and thus upstream fish passage from Buckhorn Lake or the ponds is not possible. Based on the characteristic of the watercourse as it currently exists it is best described as a permanent watercourse that does not support a fishery.

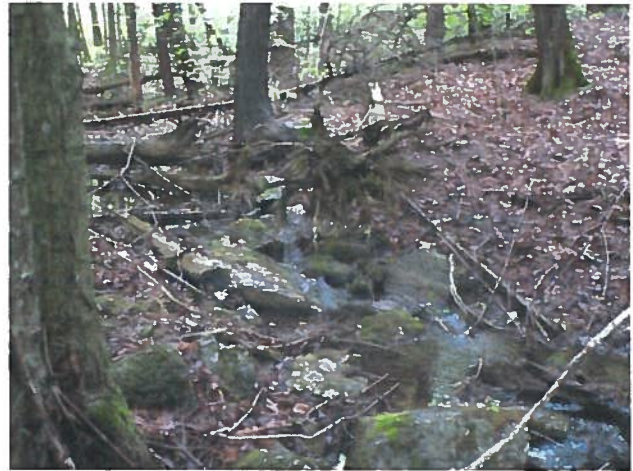
**Photo 2.** Watercourse in natural state on subject property downstream of previous photo, Lot 25 (June 11, 2013).

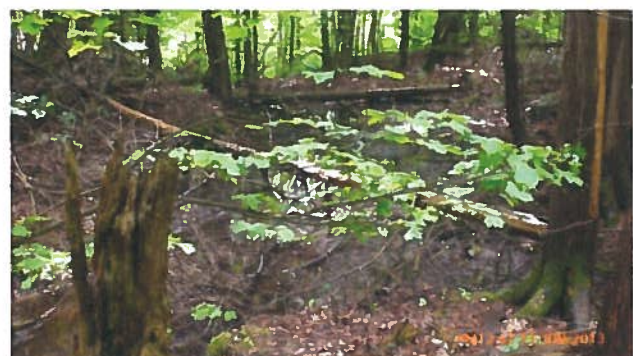
**Photo 6.** Groundwater "recharge" area, Lot 25 (June 11, 2013).

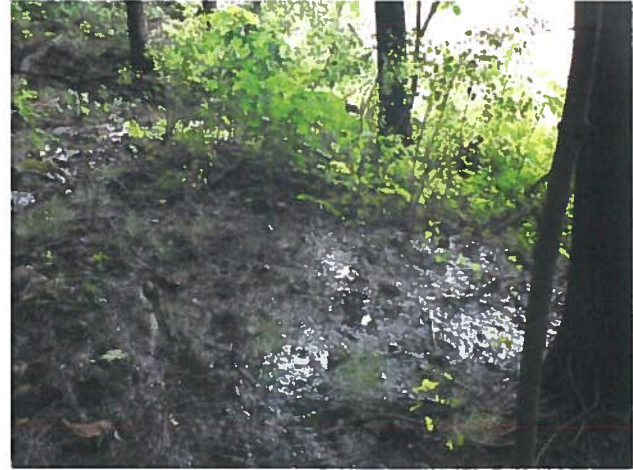
**Photo 12.** Groundwater upwelling area (June 11, 2013).

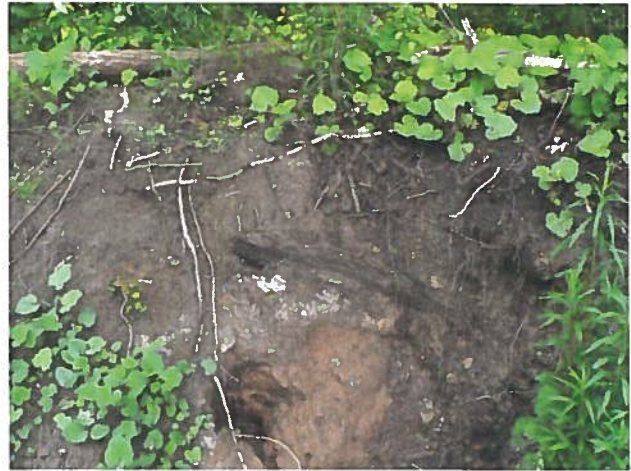
**Photo 14. Runoff from groundwater upwelling just upstream from area of braided channels (June 11, 2013).**

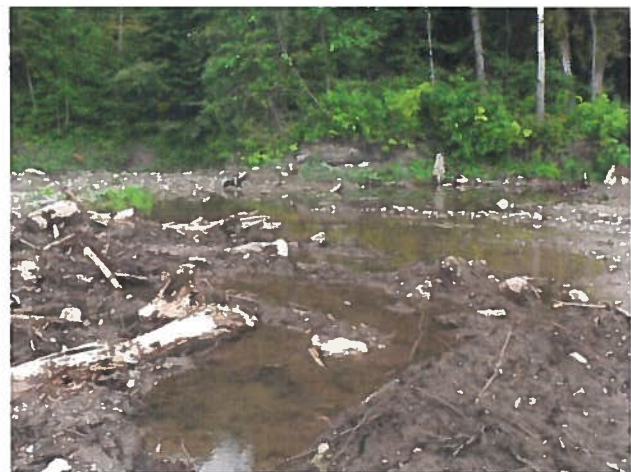
**Photo 16. Area of braided channels with disturbed areas (June 11, 2013).**

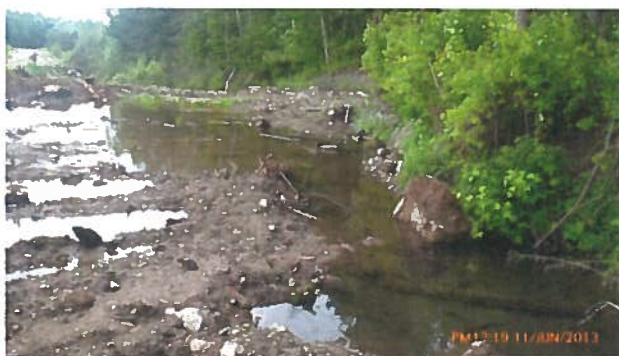
**Photo 17. Area of braided channels through disturbed soils (June 11, 2013).**

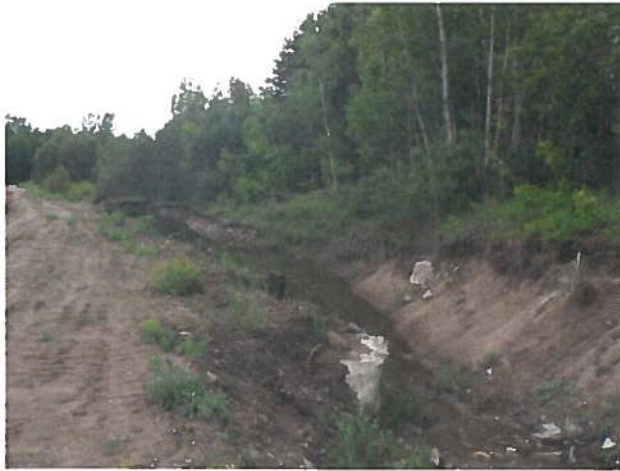
**Photo 19.** Altered watercourse adjacent to existing road, downstream of area of braided channels (June 11, 2013).

The natural watercourse ends once it enters the disturbed portions of the subject property (**Figure 2**). The flow from the natural watercourse is conveyed to the south along the west side of the internal road through a roadside ditch. The road does not currently contain any culverts; however, a series of flowing braided channels occur on the east side of the road eventually outletting to the Central Pond. It is assumed that the base flow entering the pond results from water movement through the road. The water that does not percolate through the road to the north percolates through the road at the southwestern corner of the subject property. These ditches do not directly connect to waterbodies that contain fish or contain features that would permit upstream passage by fish; therefore, these ditches do not support a fishery.

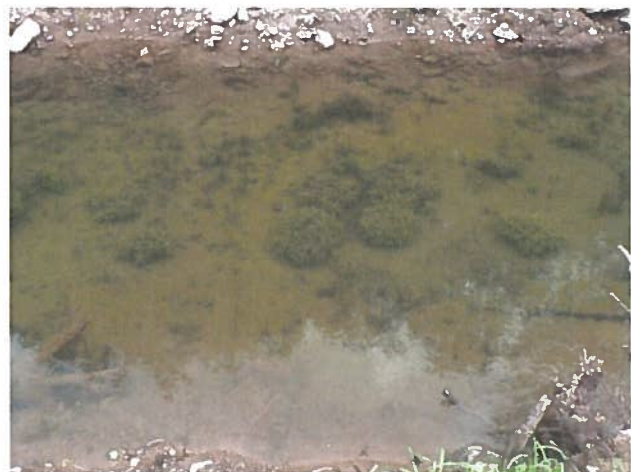
**Photo 22.** Aquatic vegetation within the altered watercourse (June 11, 2013).

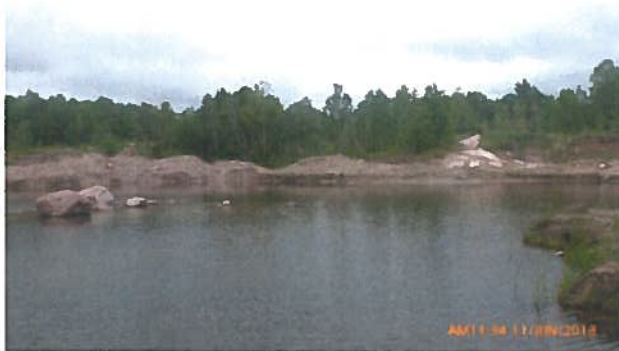
**Photo 33.** Central Pond (June 11, 2013).

There are two man-made ponds on the subject property, a large Central Pond and a smaller pond to the west. The large Central Pond is 1.6 ha in area and according to the landowner is between 6 and 9 m in depth. Many of the margins are very steep resulting from excavation activities that created the pond. The shoreline is highly disturbed and contains very little in the way of vegetation. A small bedrock outcrop is present in the central part of the pond. For the most part the pond has low habitat diversity

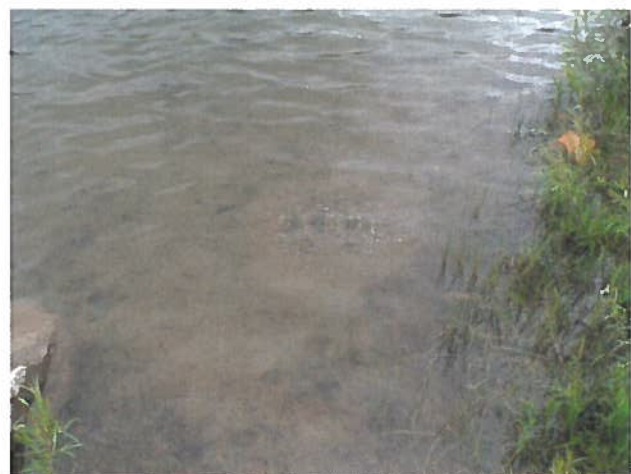
**Photo 36.** Centrarchid nest in Central Pond (June 11, 2013).

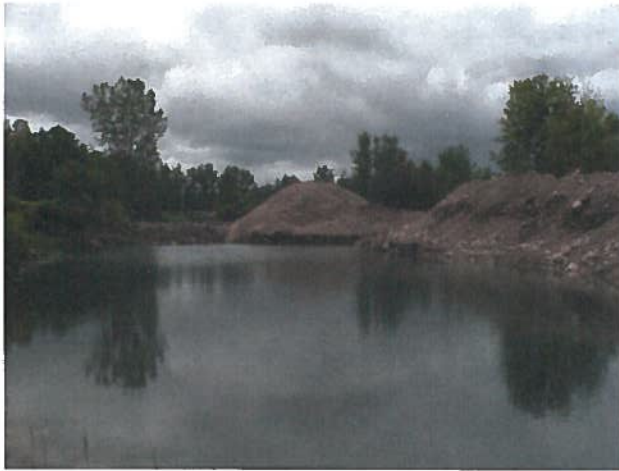
**Photo 37. West Pond (June 11, 2013).**

The West Pond appears to have been created recently because of onsite excavation activities. It is likely groundwater fed with some infiltration of water from the roadside ditch/channel that percolates through to the road. The pond has very steep margins and water depth is unknown. Brook Stickleback and other cyprinids were observed throughout the pond, interspersed amongst the aquatic vegetation. Pond banks are highly disturbed and unstable, with no vegetation. The overflow outlet from the pond consisted of a dug channel that emptied into the main outlet channel to Buckhorn Lake. Although this pond contains fish that could be used as forage for fish within Buckhorn Lake if downstream migration occurs, the size of the feature limits its ability to contribute significantly to the downstream fishery; therefore, it is RiverStone's opinion that the West Pond does not support a fishery.

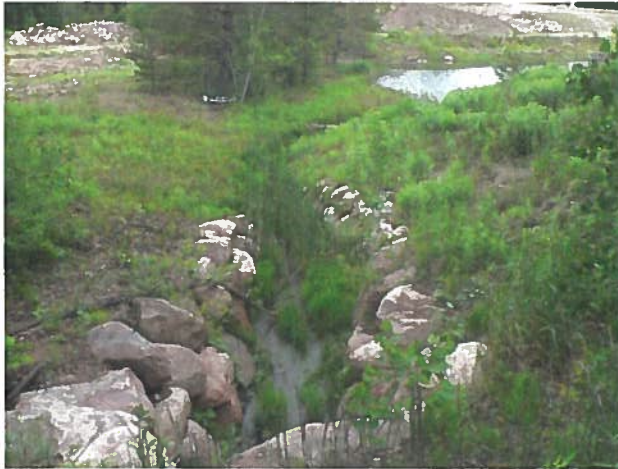
**Photo 43.** Inlet of culvert conveying pond outflow under Adam and Eve Road to Buckhorn Lake (June 11, 2013)

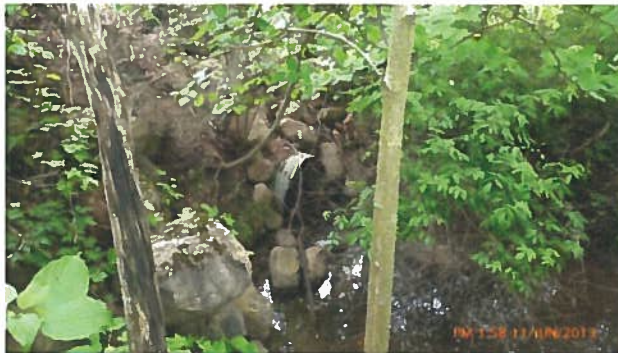
**Photo 45.** Outlet of culvert conveying base flow from the subject property under Adam and Eve Road to Buckhorn Lake (June 11, 2013).
