Environmental Impact Study

**165 Melody Bay Road
Buckhorn, Ontario**

D.M. Wills Project Number 5557

February 2024

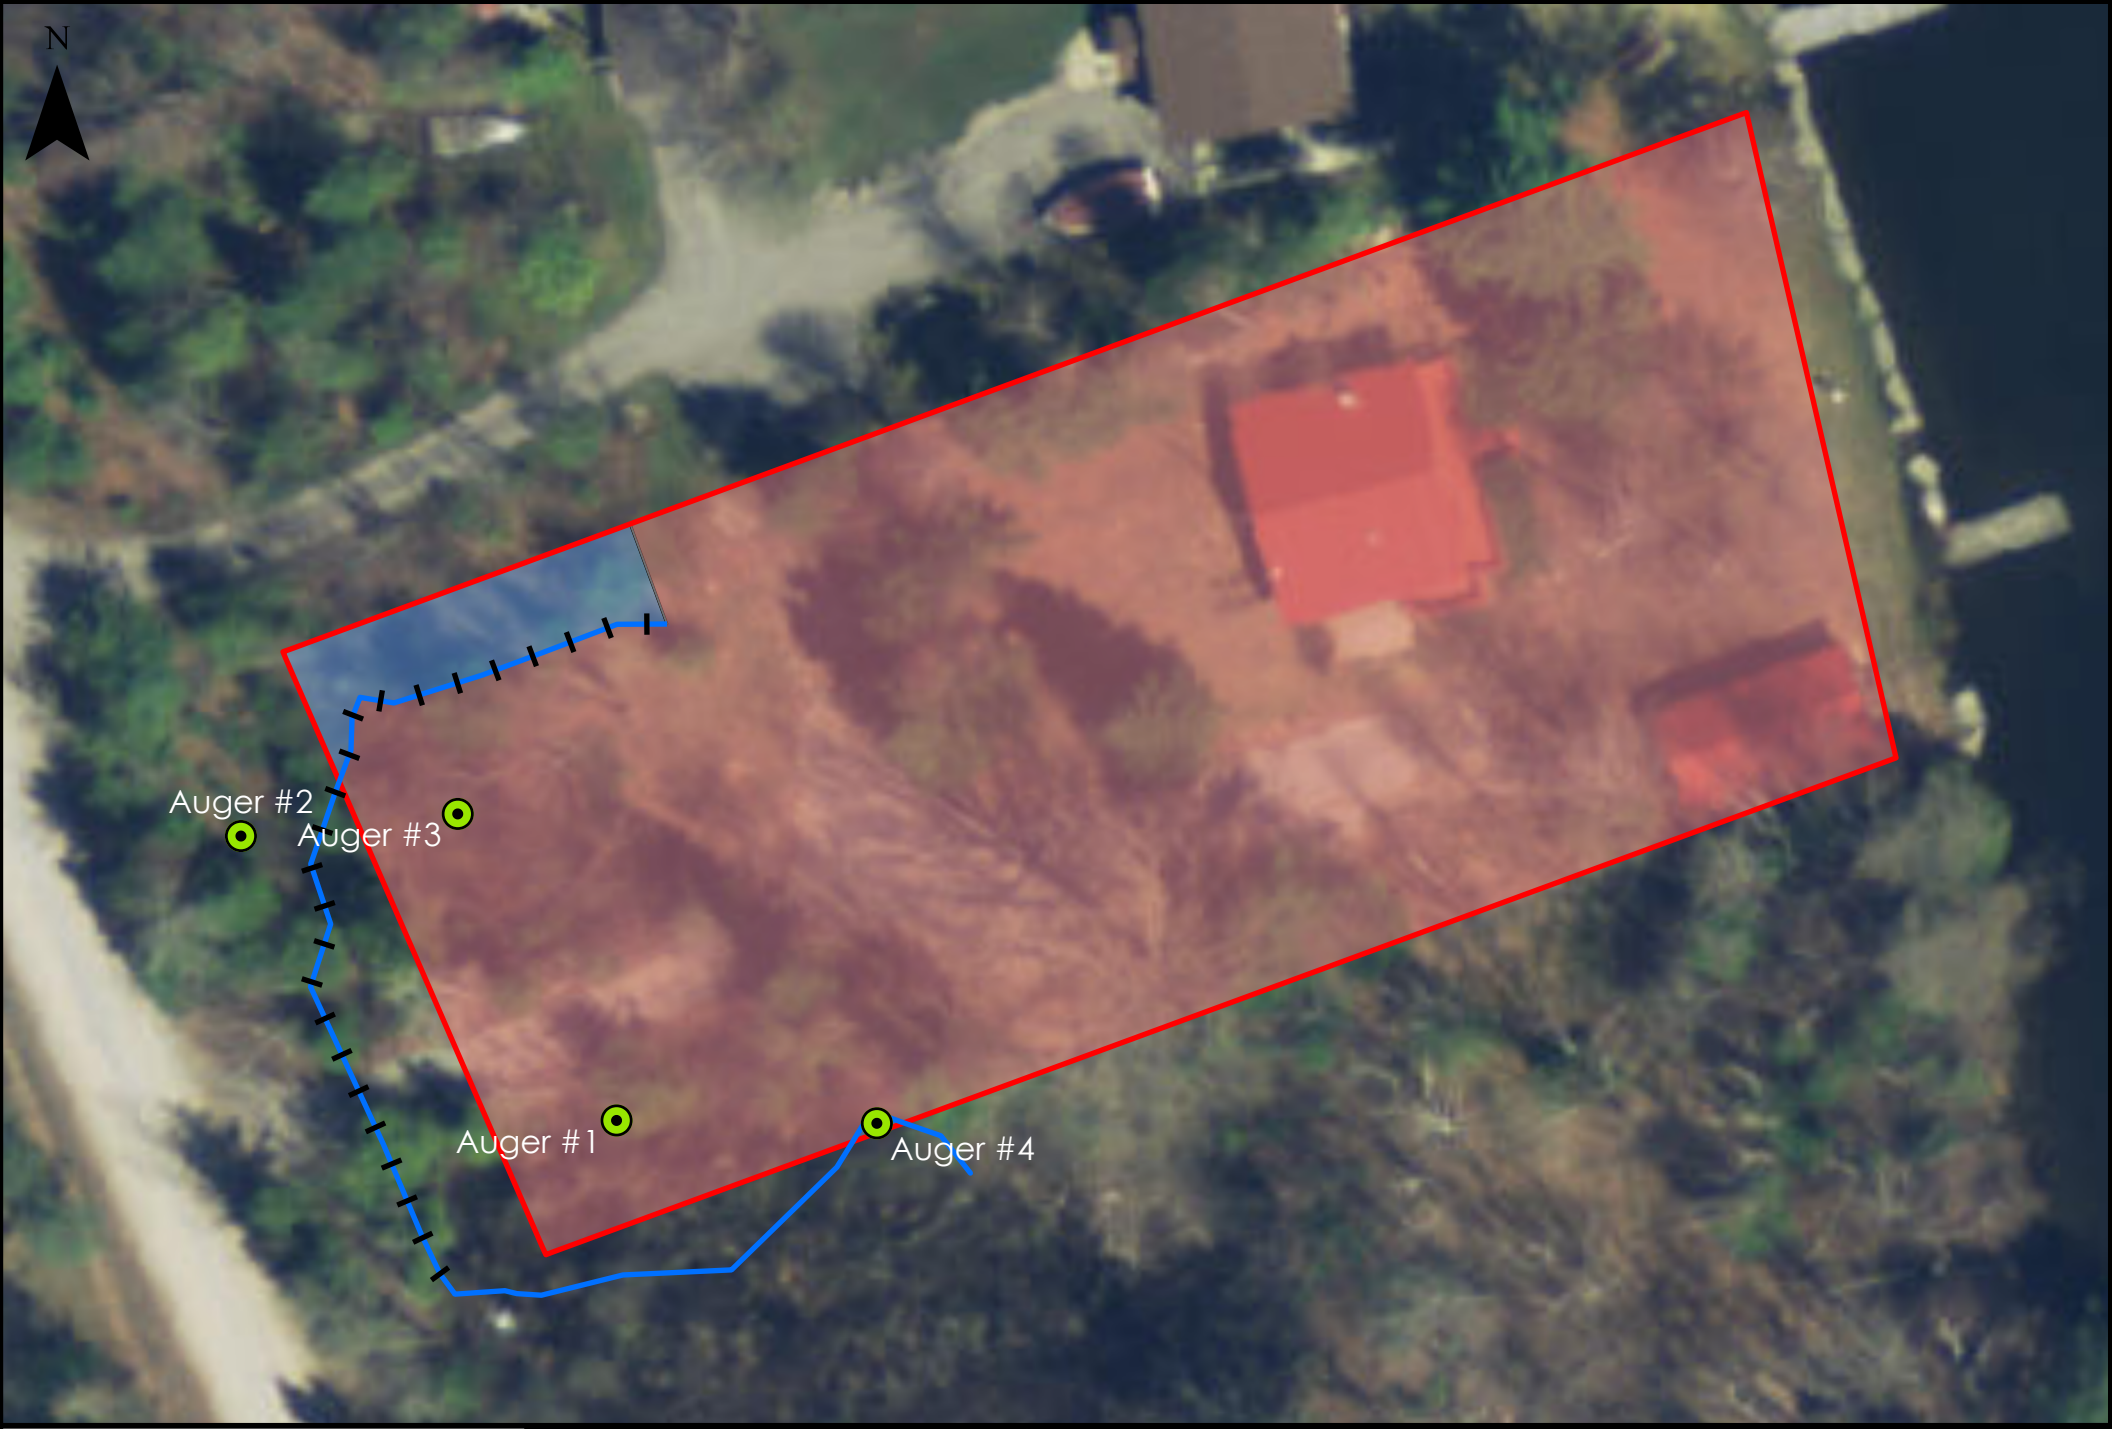
On May 11, 2023, Wills' biologists conducted a ground confirmation exercise by foot, within the Subject Property, following the Ontario Wetland Evaluation System, 2022 (OWES) standard methods for identifying wetland communities. Wills' biologists traversed the Subject Property, conducting an evaluation of wetland presence/absence in the wetland polygons indicated by NHIC mapping. When a wetland was found, the boundary was delineated using a handheld Garmin GPS, marking a waypoint approximately every 5 m. The extent of the delineated wetland boundary is shown in **Figure 3**.

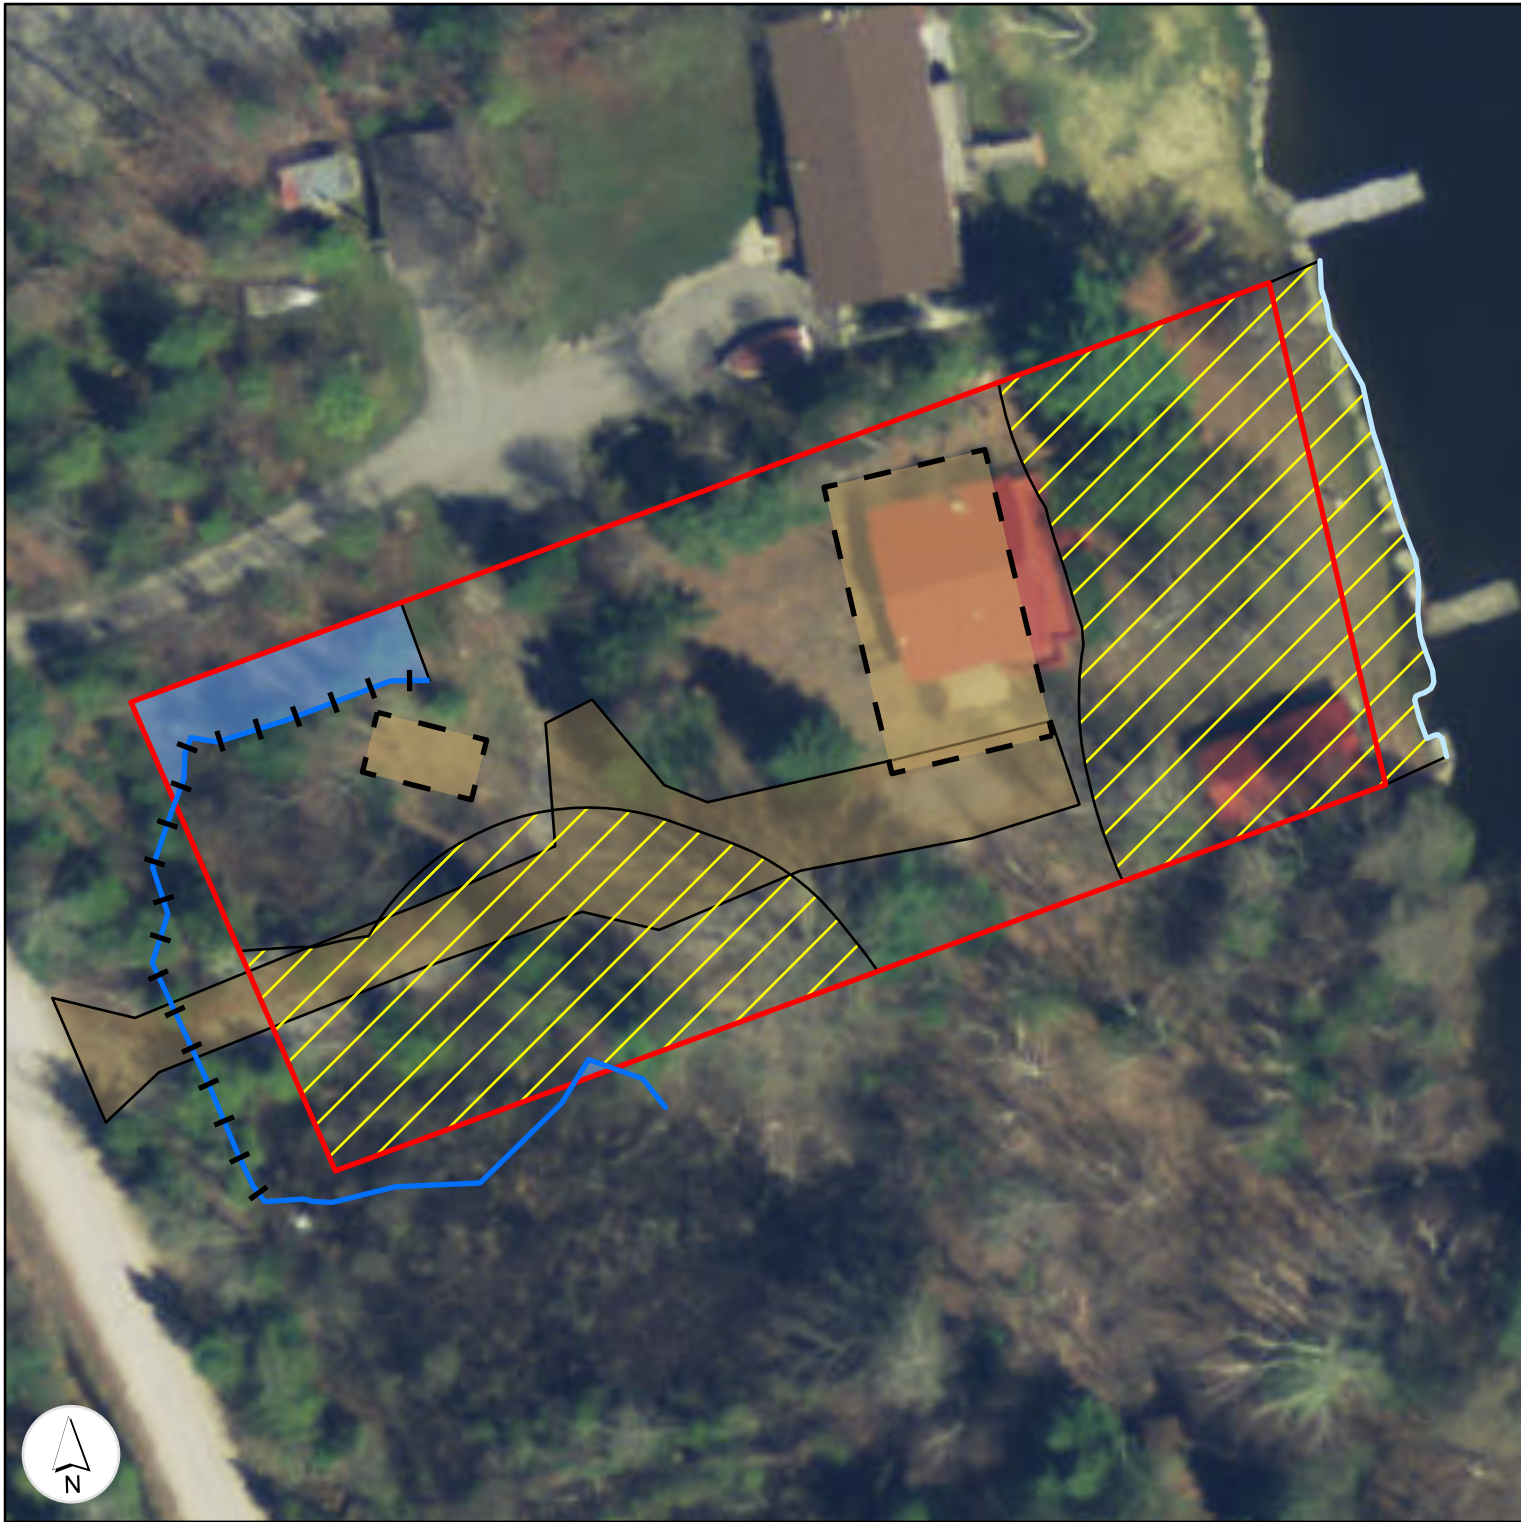
Figure 4 - Natural Heritage Constraints Map

- The implementation of a 15 m setback on the wetland situated along the southern boundary of the Subject Property (**Figure 4**).
- A Vegetation Planting Plan within the 15 m setback to provide protection to the wetland community (**Figure 5**).
- The implementation of a 20 m setback from the high-water mark of Buckhorn Lake (**Figure 4**).
- The implementation of an Erosion and Sediment Control measures including stockpiling and isolating waste material outside of the setbacks identified in **Figure 4**.
- A breeding bird timing window where vegetation must be removed outside of **April 5th to August 31st**.
- It is recommended that a qualified professional be retained to perform a health assessment of the Black Ash (Endangered) identified on the Subject Property.

- Waste material should be contained and stabilized outside of the buffers identified in **Figure 4**. Alternatively, waste materials should be removed off-site.
- Inspection and maintenance of erosion and sediment control measures and structures should take place during the course of construction.
- Erosion and sediment control measures and structures should be repaired if damage occurs.
- Site isolation measures for containing stockpiled material should be implemented.
- A response plan should be developed that will be implemented immediately in the event of a sediment release or spill of a deleterious substance.

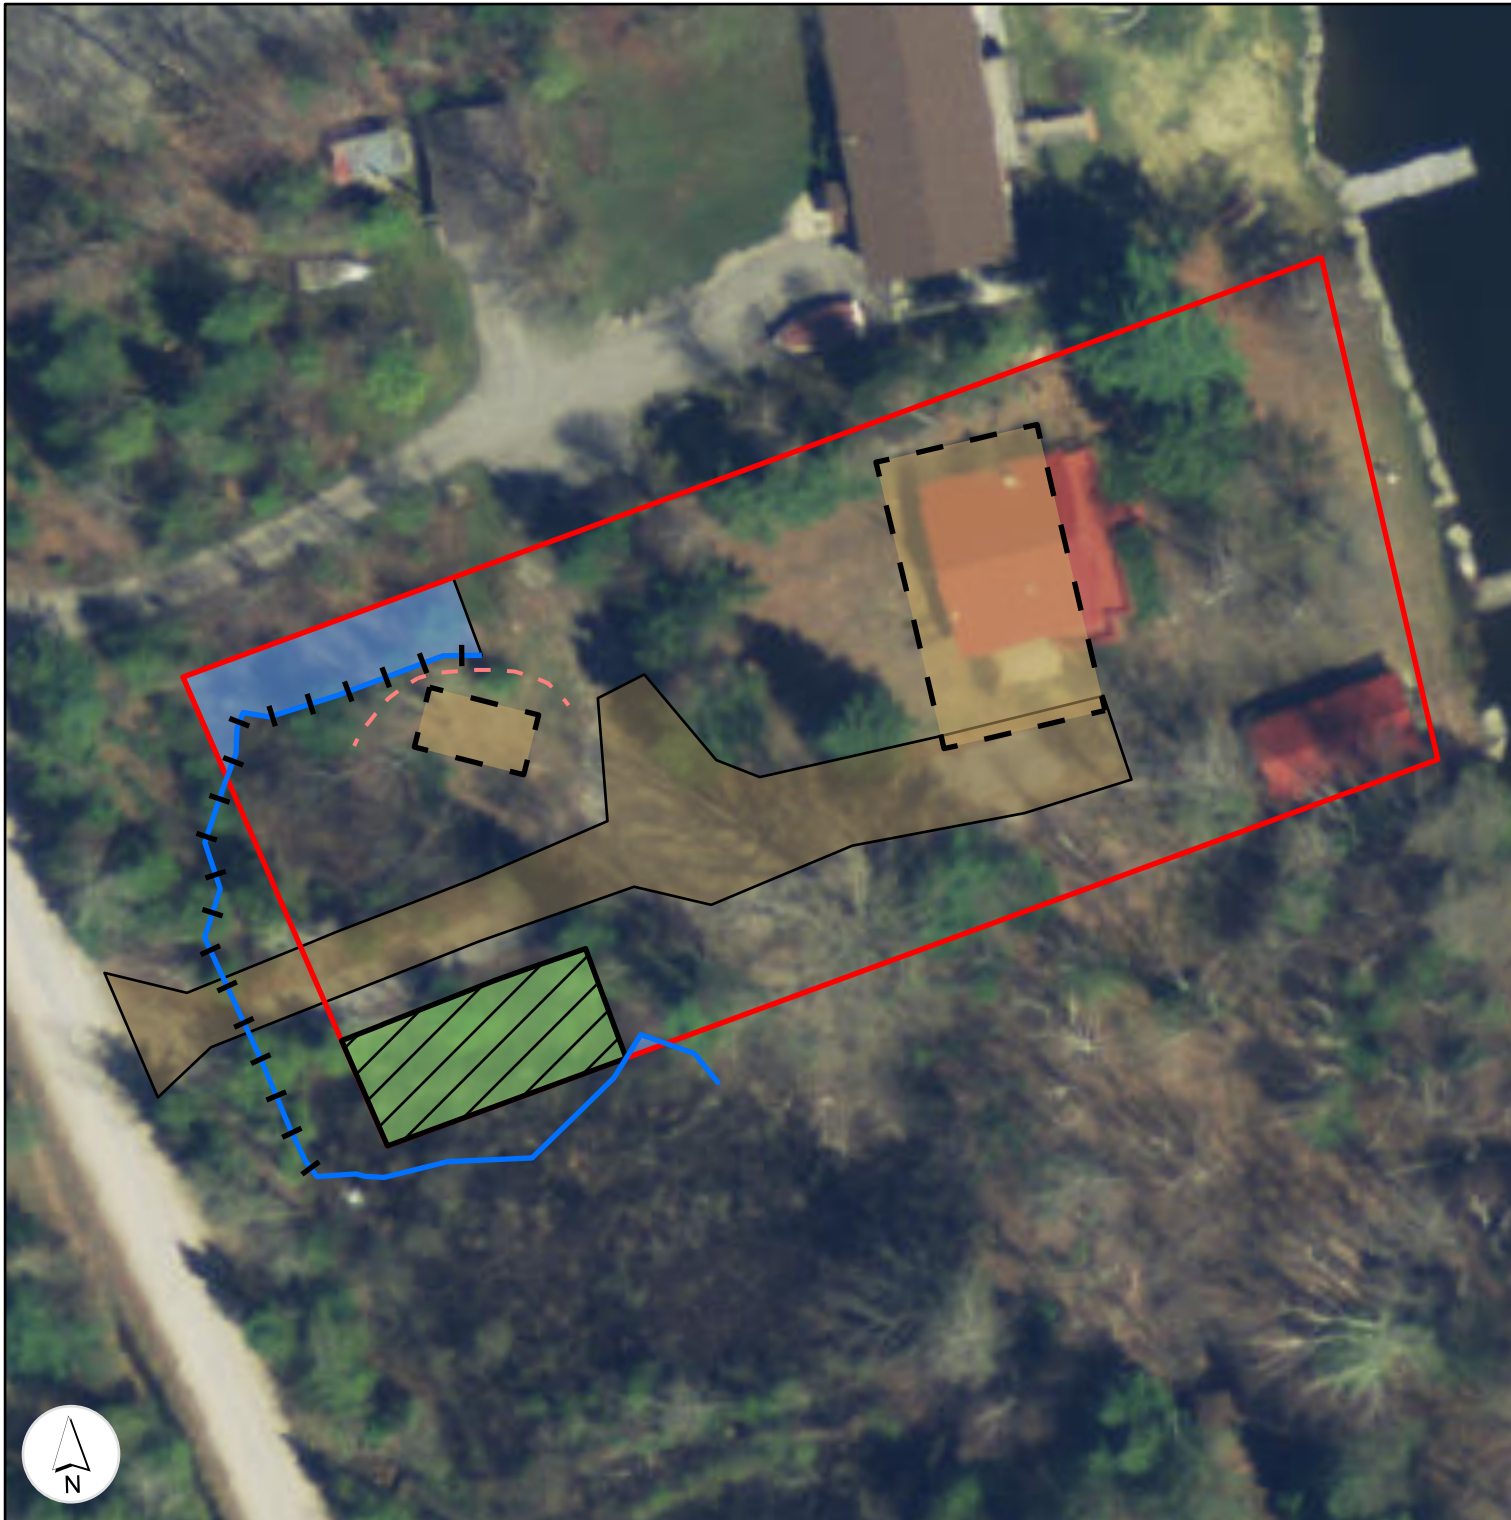
Figure 5 - Planting Area & Sediment Fencing Map

- The Vegetation Planting Plan outlined in **Section 4.3** should be implemented within the recommended buffer as shown in **Figure 5**.
- Mitigation measures described in **Section 4.5** should be implemented to ensure no negative impacts to wetland occur during construction.

The planting area identified in **Figure 5** will be planted with native tree species observed to occur on the Subject Property during the May 11, 2023, site investigation. **Table 3** provides a non-exhaustive list of native tree species recommended to be incorporated into the Planting Plan which can adapt to both wetland and upland environments.

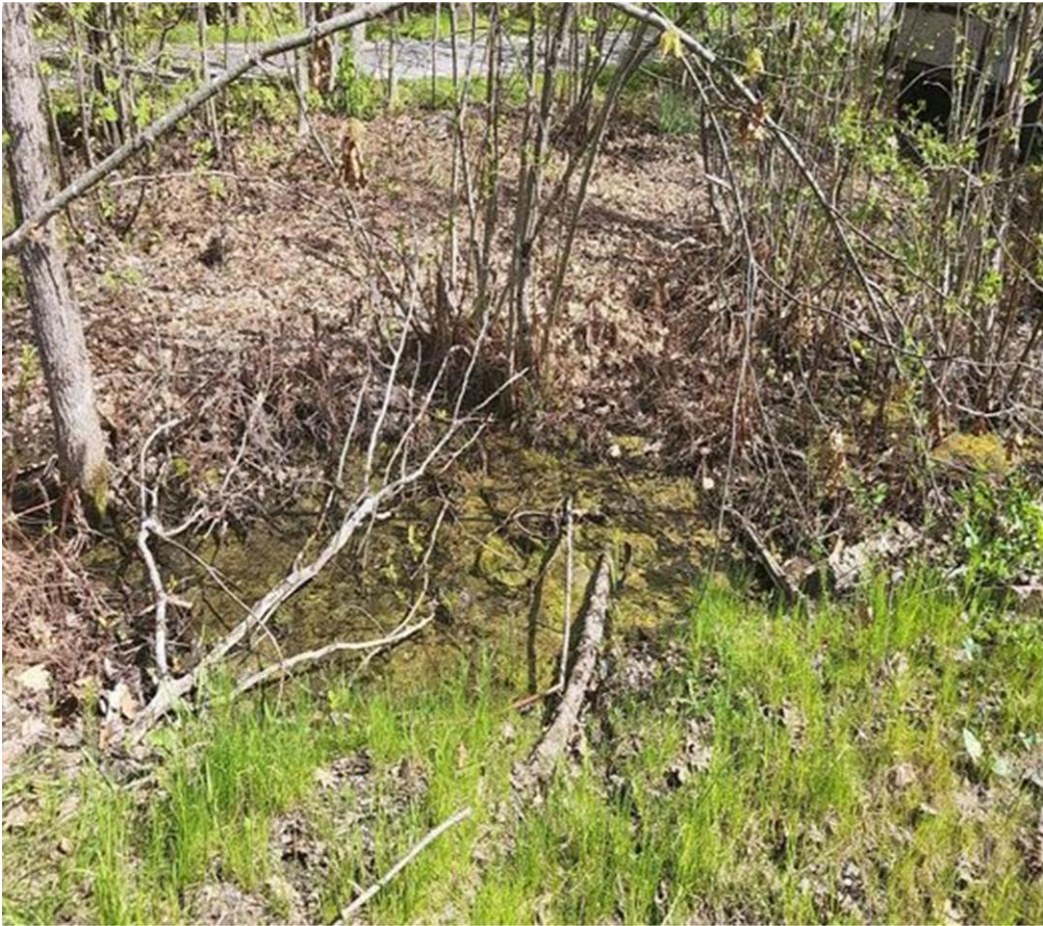
Photo Description:
Impacted wetland along northern boundary of Subject Property bordered to the north by driveway and to the south by a manicured lawn.

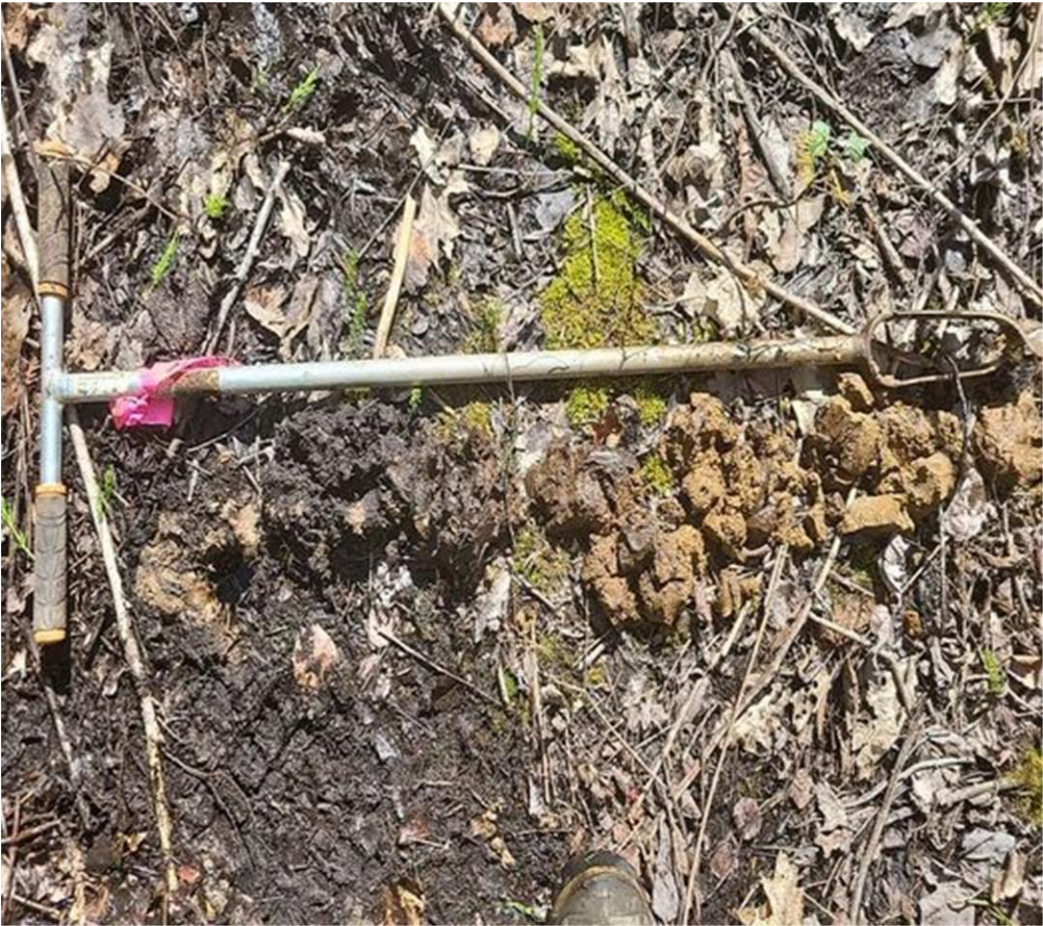
Photo # 6

Photo Description:
Soil Auger #2 retrieved from wetland community.

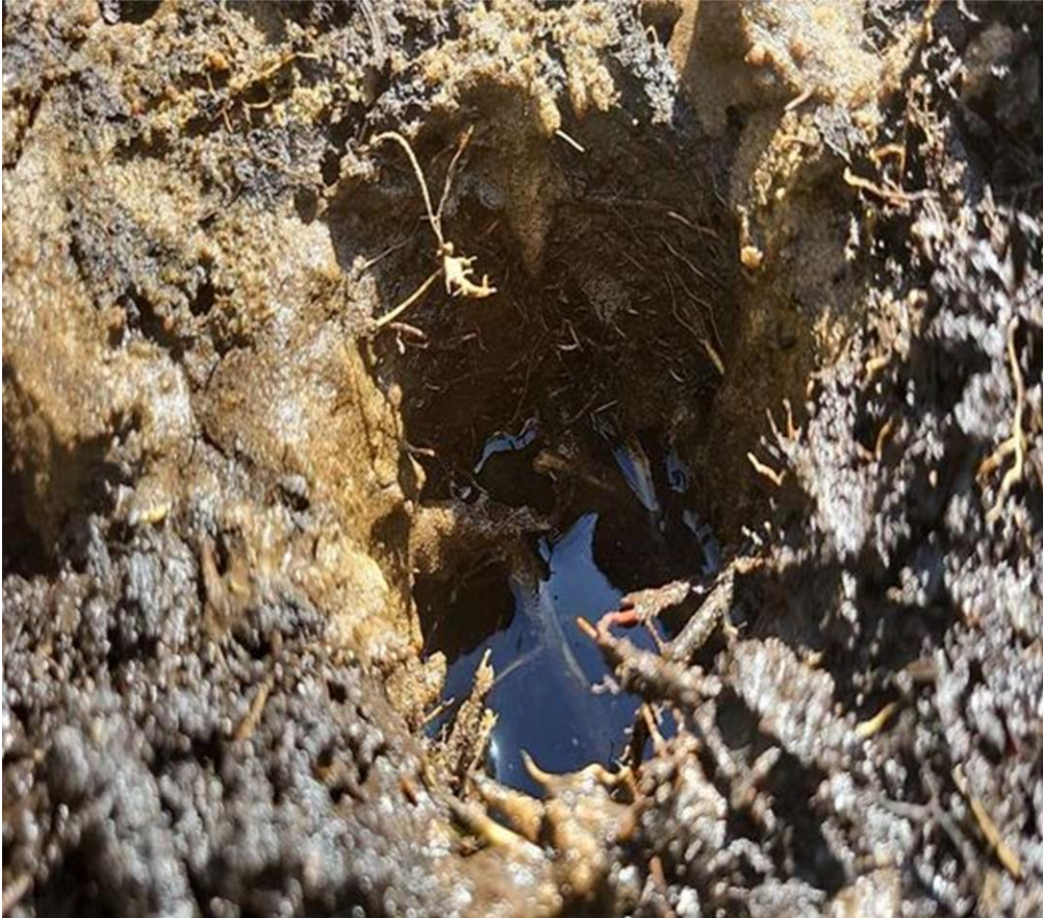
Photo # 7

Photo Description:
Water table near ground surface at Auger #2.

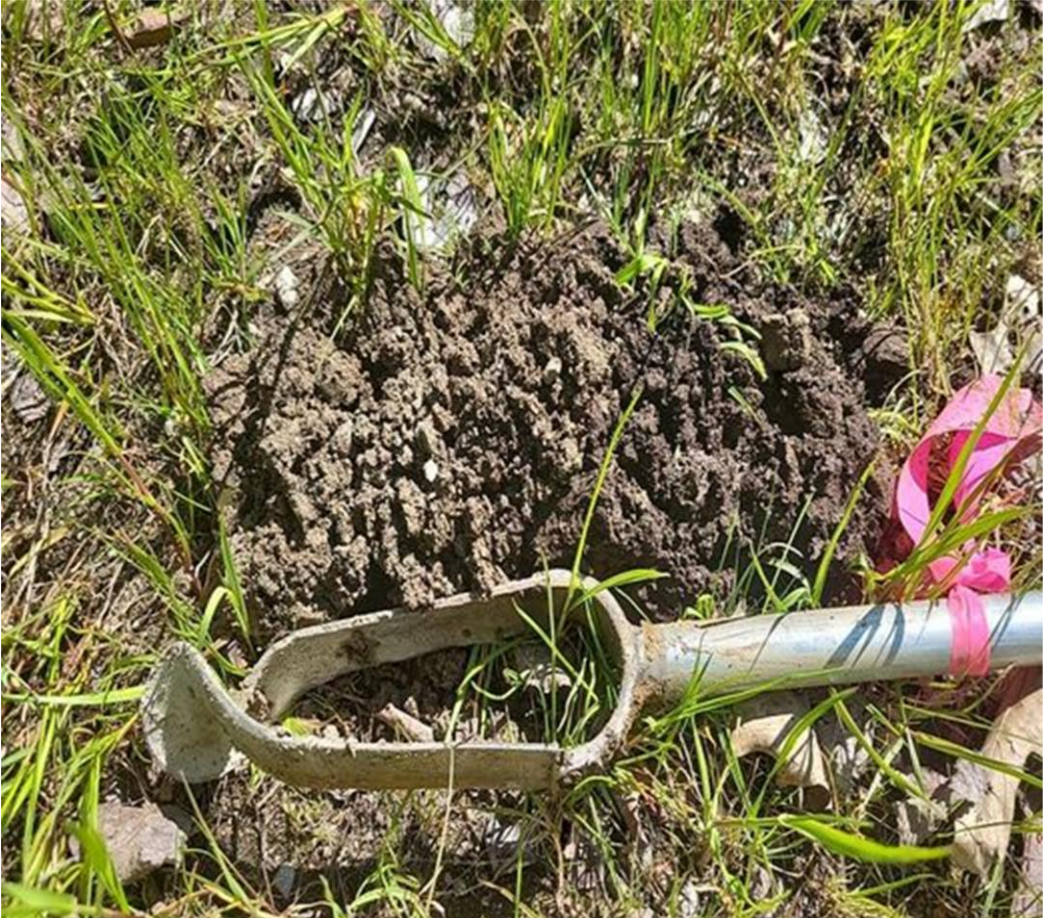
Photo # 8

Photo Description:
Soil Auger #3 retrieved from manicured grass community

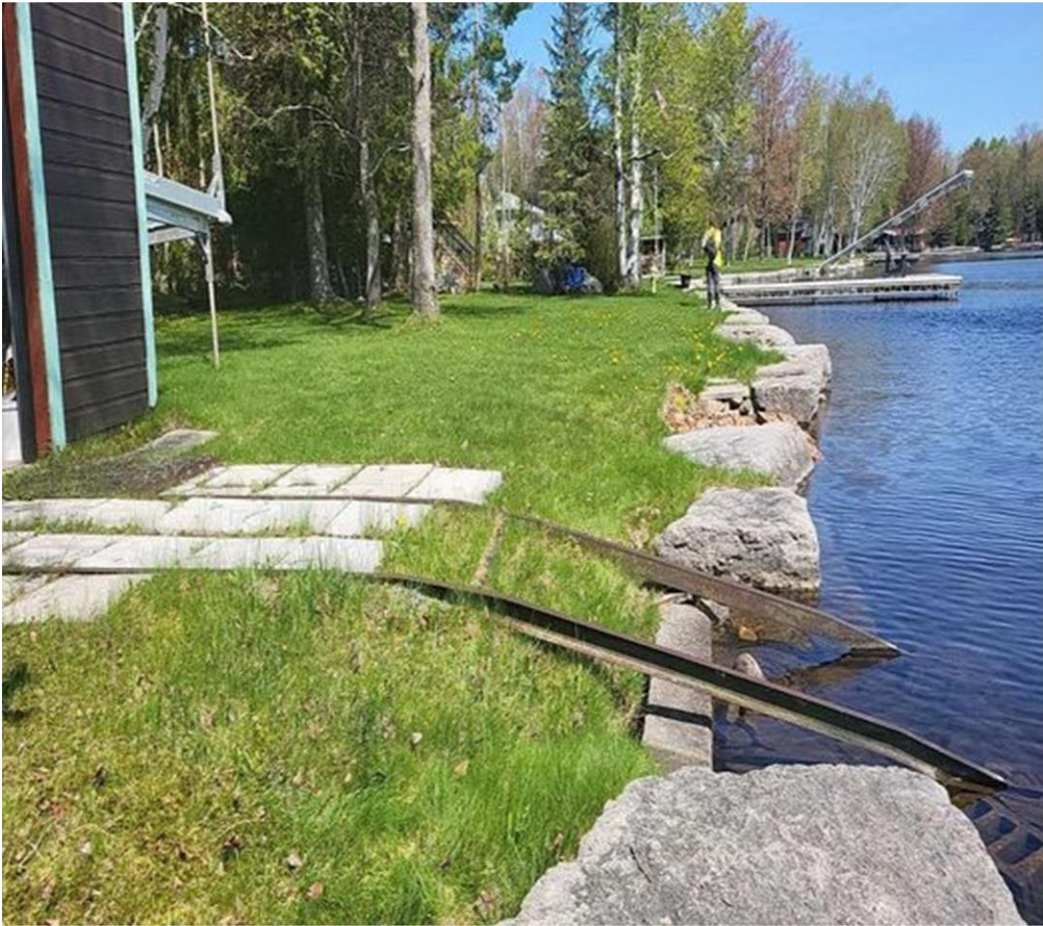
<div>Photo # 9</div> <div>Location: 44.54221 -78.35924</div> <div>Photo Direction: Northeast</div> <div>Date: 2023/05/11</div> <div>Photo Description: Shoreline of existing property abutting Buckhorn Lake.</div>

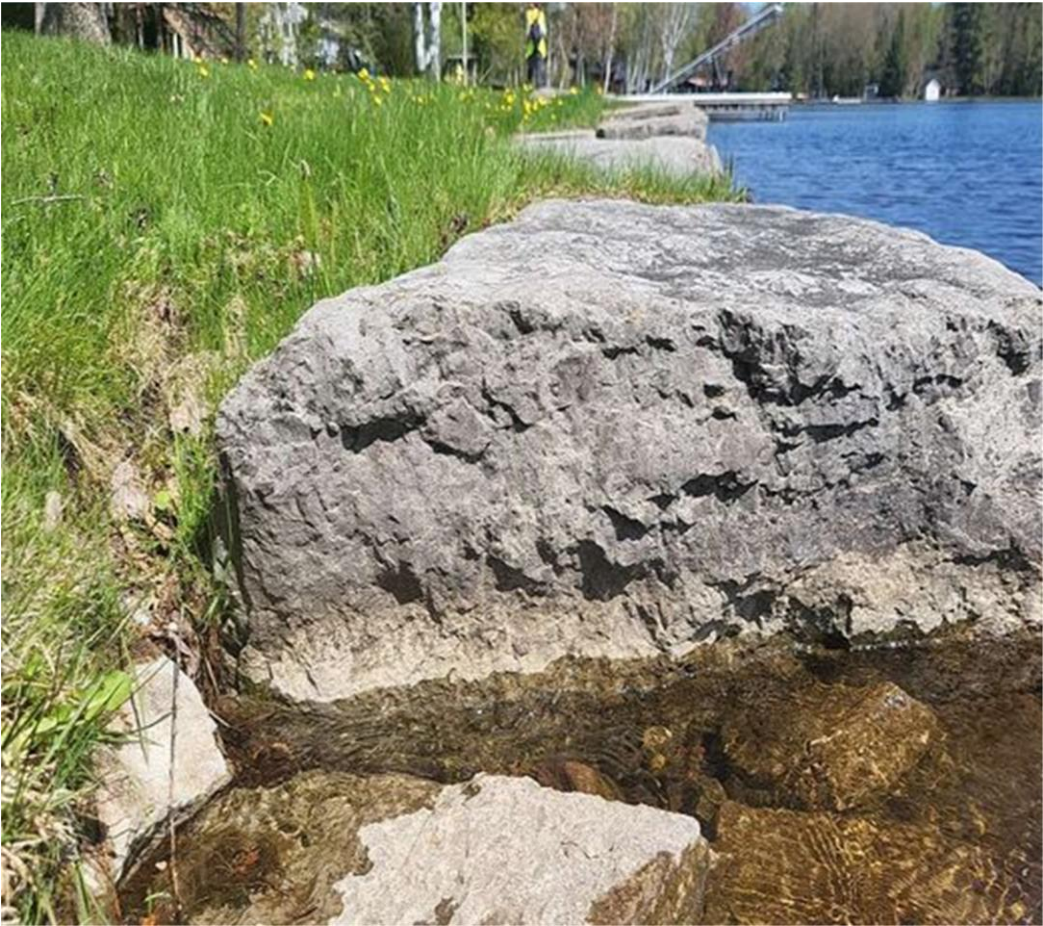
<div>Photo # 10</div> <div>Location: 44.54228 -78.35925</div> <div>Photo Direction: Northeast</div> <div>Date: 2023/05/11</div> <div>Photo Description: Evidence of high-water mark along Shoreline of Buckhorn Lake</div>

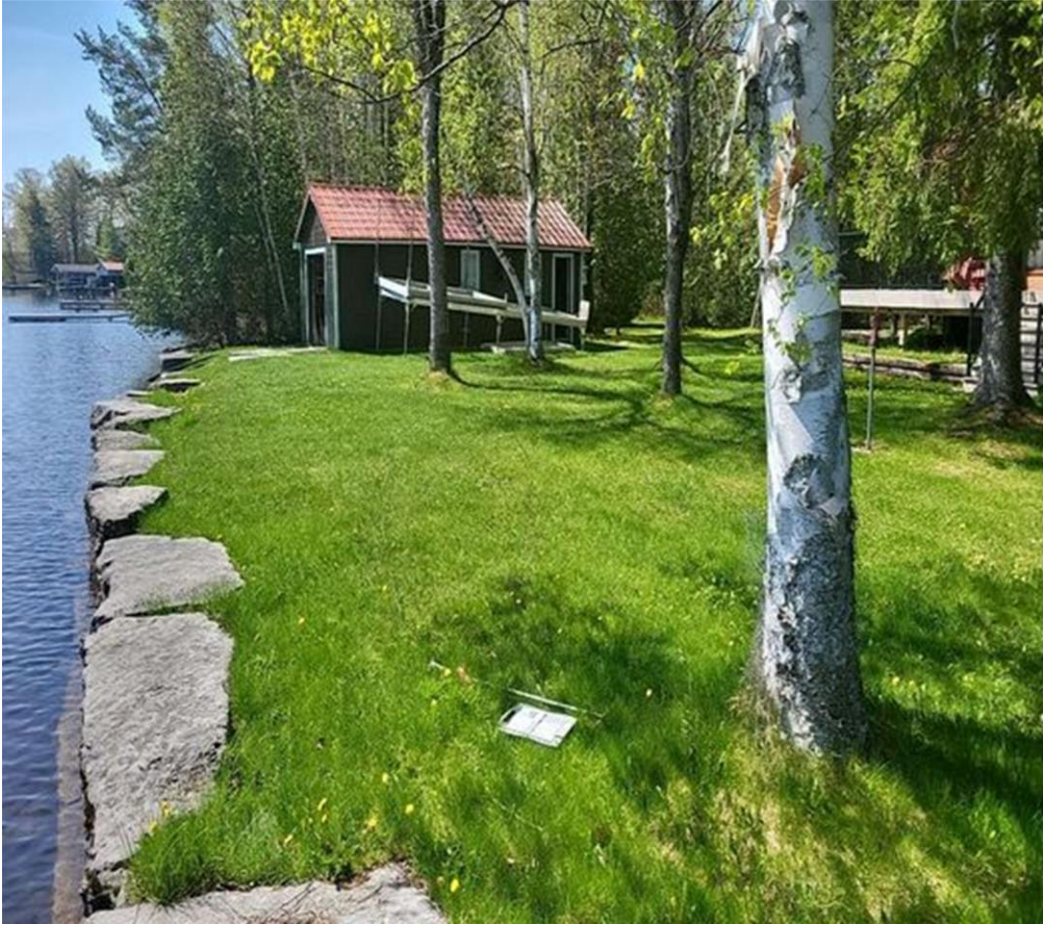
<div>Photo # 11</div> <div>Location: 44.54249 -78.35935</div> <div>Photo Direction: South</div> <div>Date: 2023/05/11</div> <div>Photo Description: Shoreline of existing property abutting Buckhorn Lake.</div>

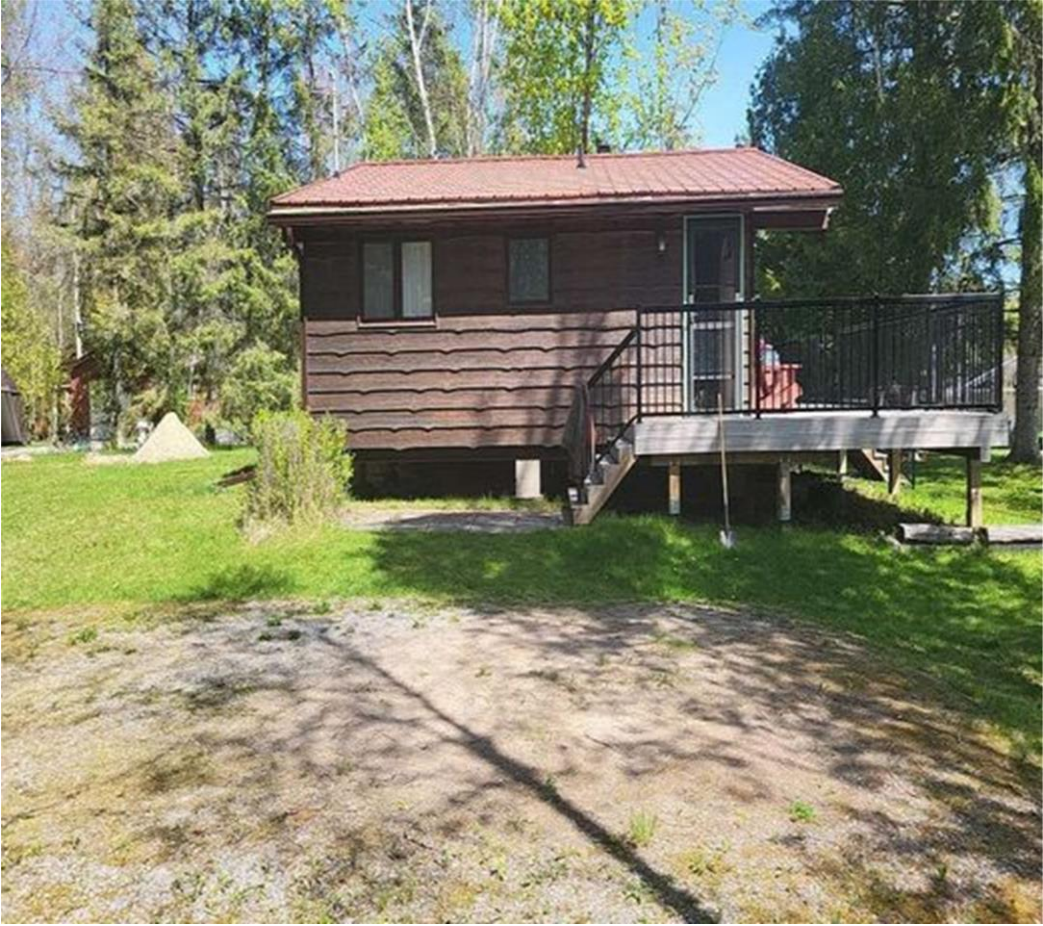
<div>Photo # 12</div> <div>Location: 44.54218 -78.35954</div> <div>Photo Direction: North</div> <div>Date: 2023/05/11</div> <div>Photo Description: Proposed cottage expansion location.</div>

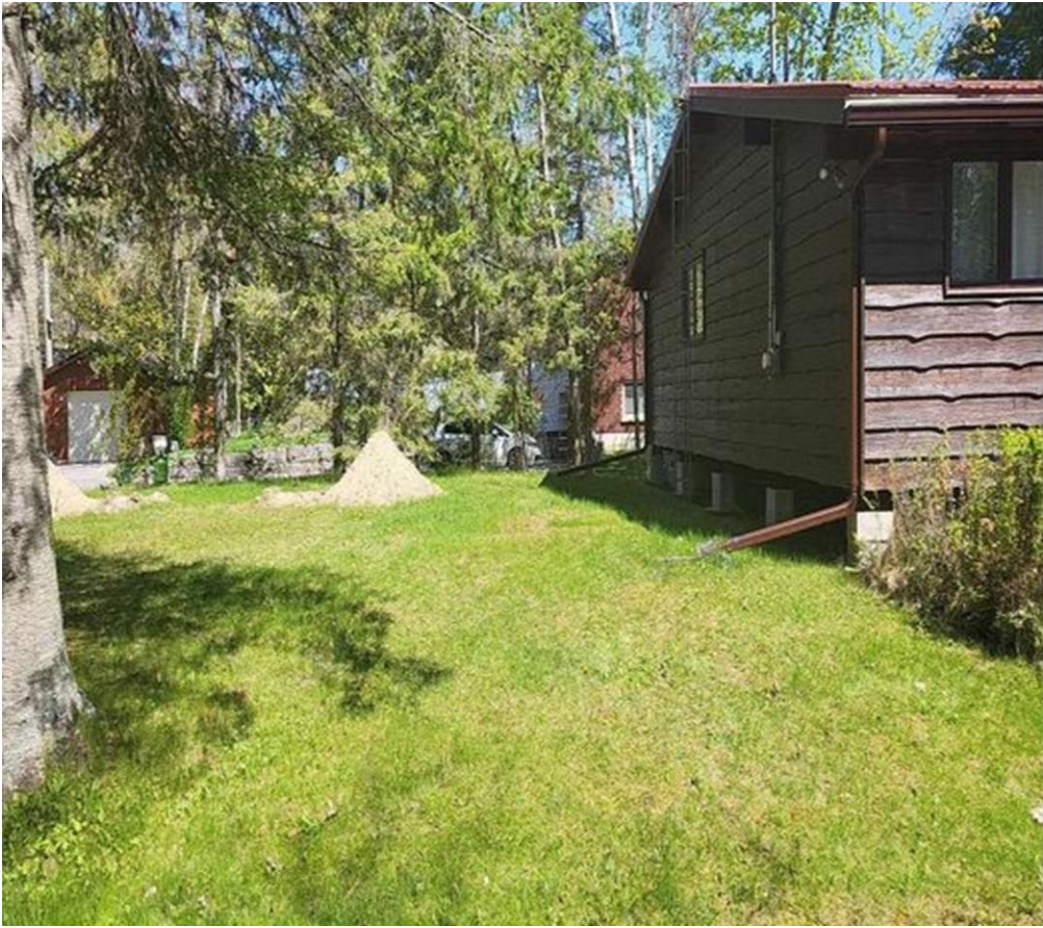
<div>Photo # 13</div> <div>Location: 44.5422 -78.35968</div> <div>Photo Direction: Northeast</div> <div>Date: 2023/05/11</div> <div>Photo Description: Proposed cottage expansion location.</div>

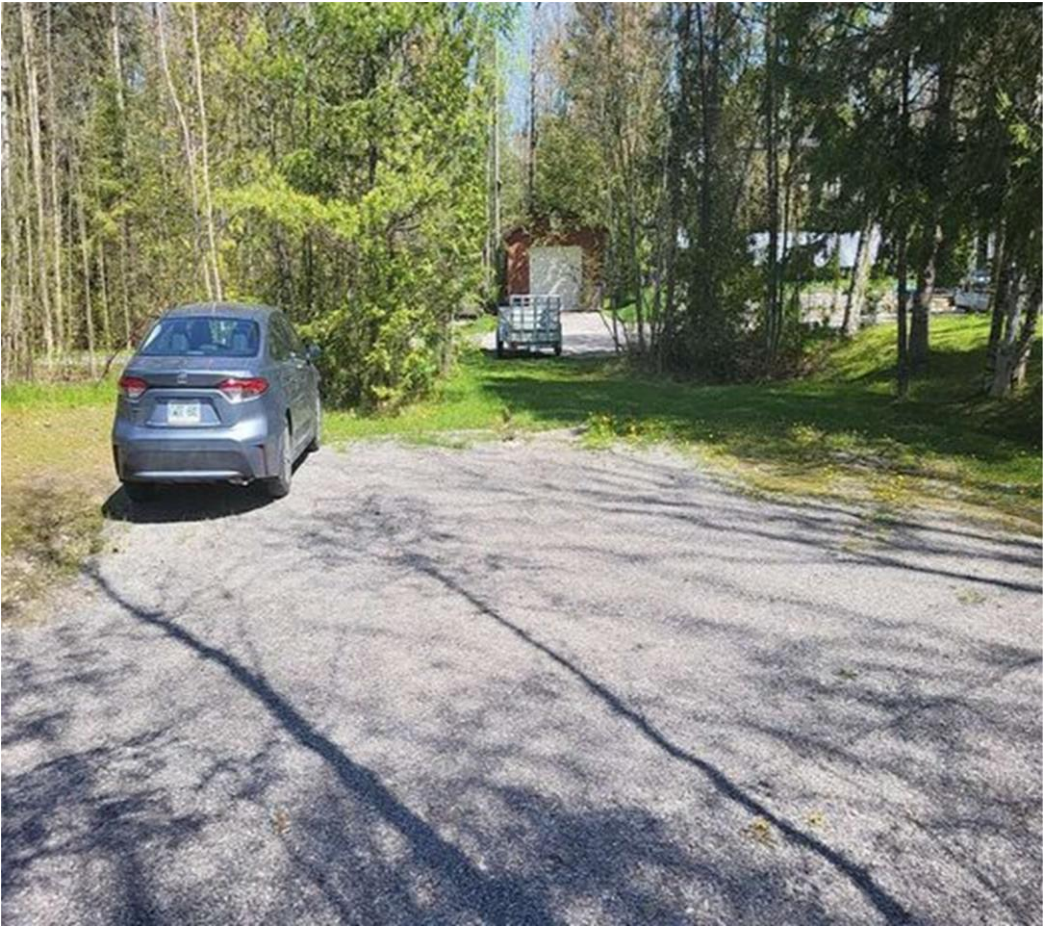
<div>Photo # 14</div> <div>Location: 44.54221 -78.35979</div> <div>Photo Direction: West</div> <div>Date: 2023/05/11</div> <div>Photo Description: Proposed garage location</div>

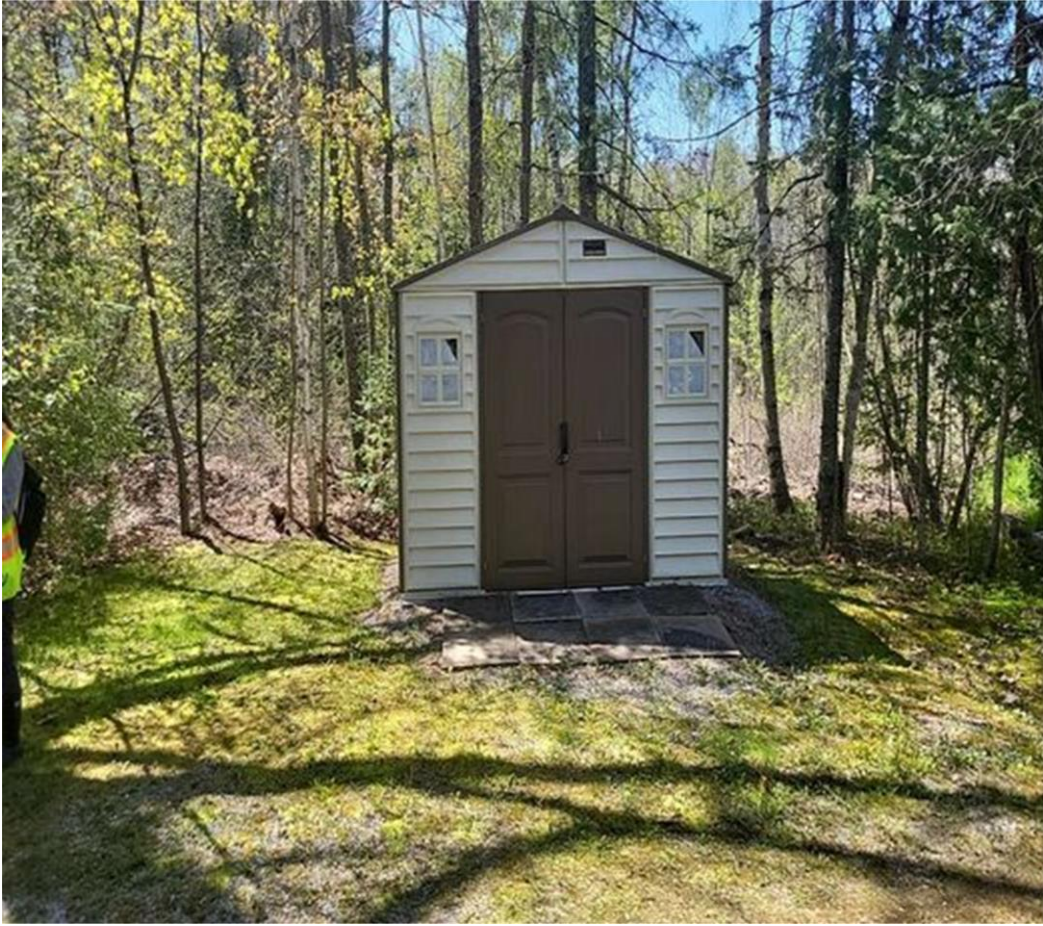
<div>Photo # 15</div> <div>Location: 44.54221 -78.35981</div> <div>Photo Direction: Southeast</div> <div>Date: 2023/05/11</div> <div>Photo Description: Existing shed.</div>

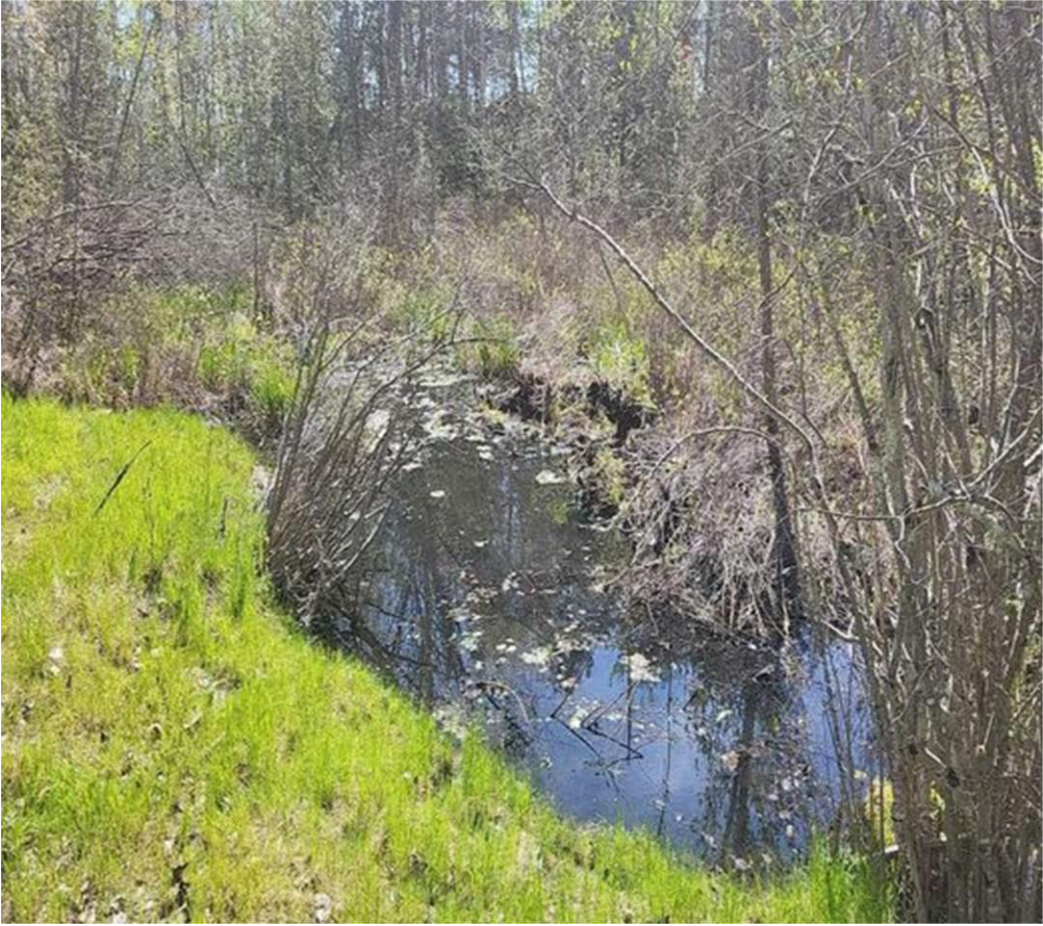
<div>Photo # 16</div> <div>Location: 44.54215 -78.35993</div> <div>Photo Direction: Southeast</div> <div>Date: 2023/05/11</div> <div>Photo Description: Wetland community to the south of the Subject Property.</div>
