Re: Development on existing lot
14 William Street
Municipality of Trent Lakes

Scoped Environmental Impact Study

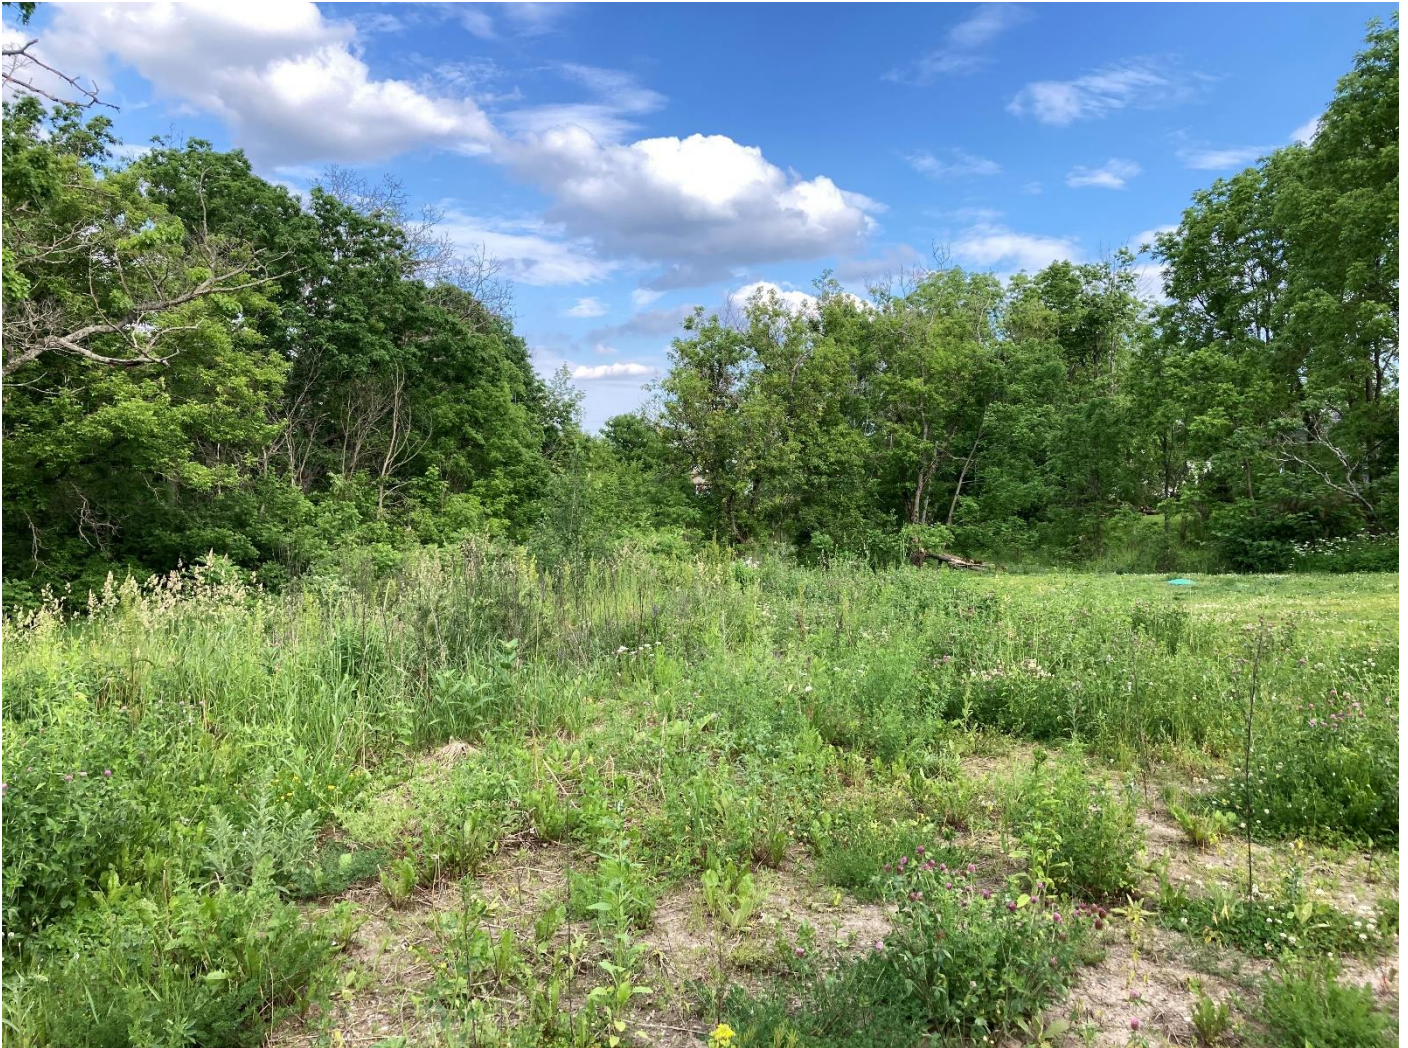
Community 1 was an upland area in the proposed footprint. The area was an upland early successional meadow with some exposed granite bedrock. This community included open field along the edges with, common blackberry (*Rubus alleghaniensis*), field hawkweed (*Pilosella caespitosa*) awnless brome grass (*Bromus inermis*), poverty grass (*Danthonia spicata*), red clover (*Trifolium pratense*), orchard grass (*Dactylis glomerata*), Viper's bugloss (*Origanum vulgare*), mossy stonescrop sedum (*Sedum acre*), white bedstraw (*Galium album*), and a few curled dock (*Rumex crispus*).

Photo 1. Upland area of site (Photo date: April 30 2024-facing south).

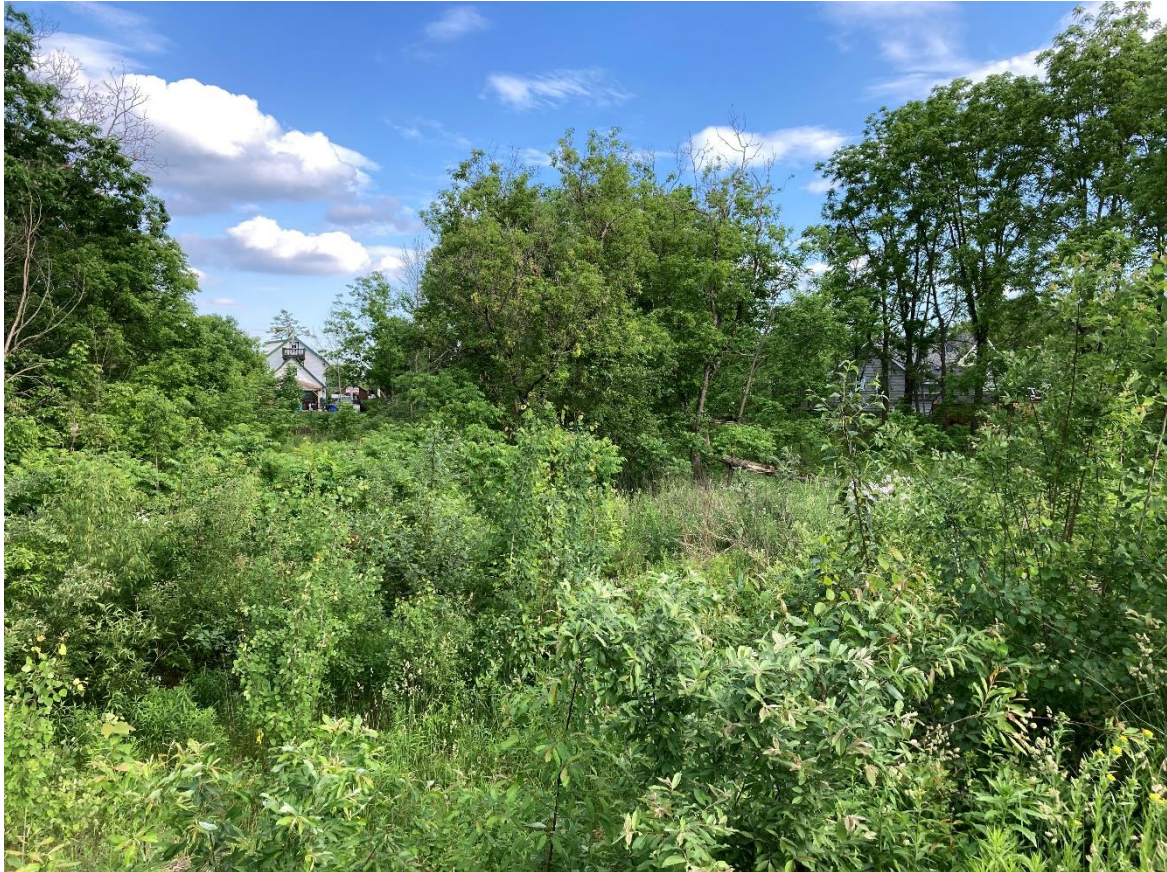
To the south east, there was a dip in the bedrock that created a low swale. Drainage from the adjacent lots created a moist low lying pocket (60 square metres). Species included red-osier dogwood (*cornus stolonifera*), willow species that was dominant, balsam poplar (*Populus balsamifera*) saplings and narrow-leaved cattail *Typha angustifolia*). The low area is associated with the drainage ditch downstream to the east.

Photo 2. Swamp and drainage area at south end of property.

No impacts on the ecological functions of the unevaluated wetland is anticipated as the footprint of the triplex and septic is outside of this feature. The function is very limited on the small wetland pocket and as such retention is not recommended. A minimum 5 m buffer is recommended from this feature.

6. A 5 m buffer from the wetland be delineated.

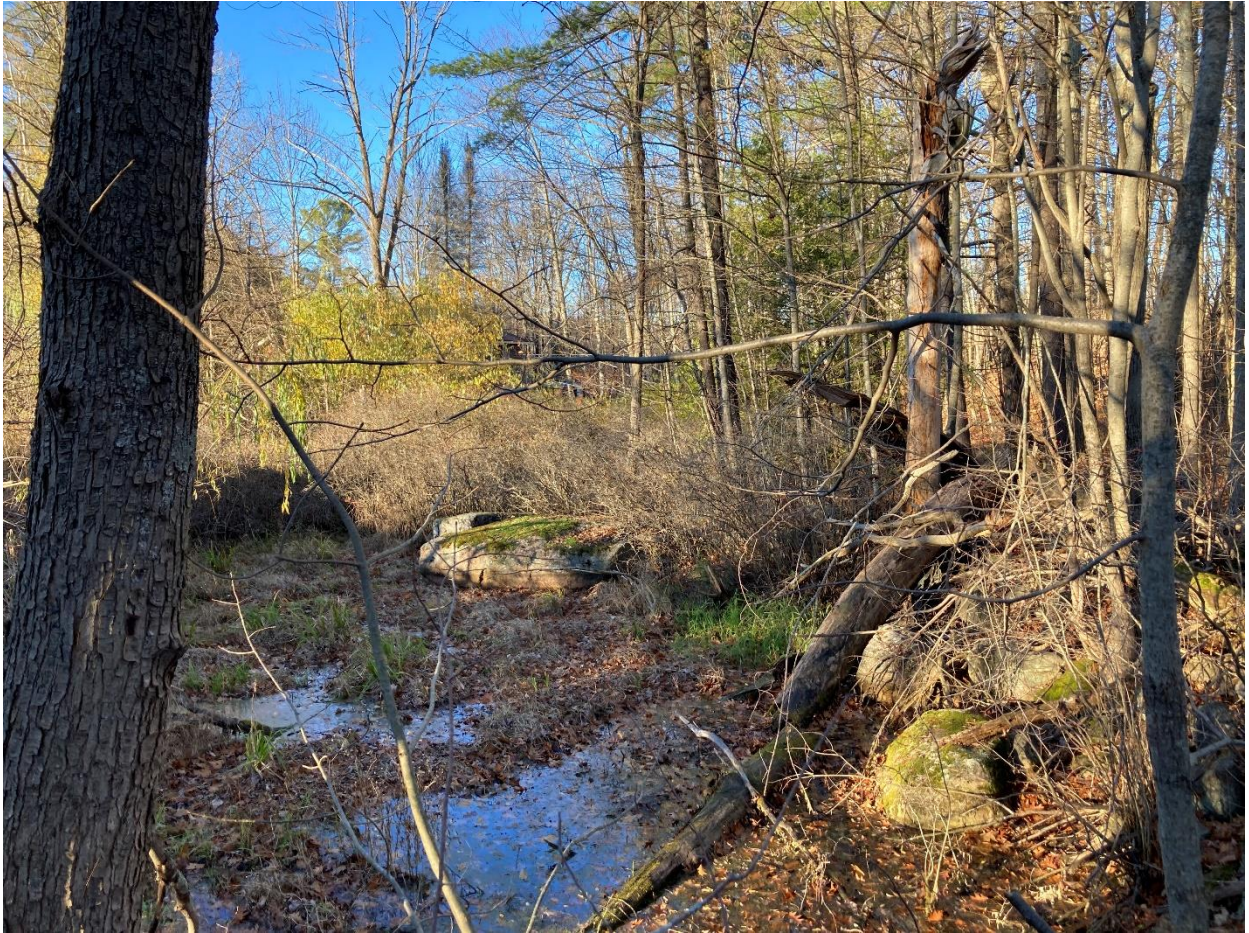
The area to the southeast and off property a dug channel and edge of field stone. The low part of the channel was wet with red-osier dogwood, balsam poplar and willow. The upland areas were a mix of a mixed forest with eastern white pine (*Pinus strobus*), trembling aspen (*Populus tremuloides*), balsam poplar and red oak (*Quercus rubra*). Understory plants included prickly gooseberry (*Ribes cysosbati*), herb Robert (*Geranium robertianum*), barren strawberry (*Waldsteinia fragarioildes*), trout lily (*Erythronium Americanum*) and yellow avens (*Geum allepicum*).

Photo 3. View of dug channel lined with field stone and wetland, mostly off site to east and southeast.
